1.6 HDi PSA Engine DV6TED4

**Evidence of carbon
build up in a 1.6 HDi
PSA Group engine
leading to total
turbocharger failure**

Case Study

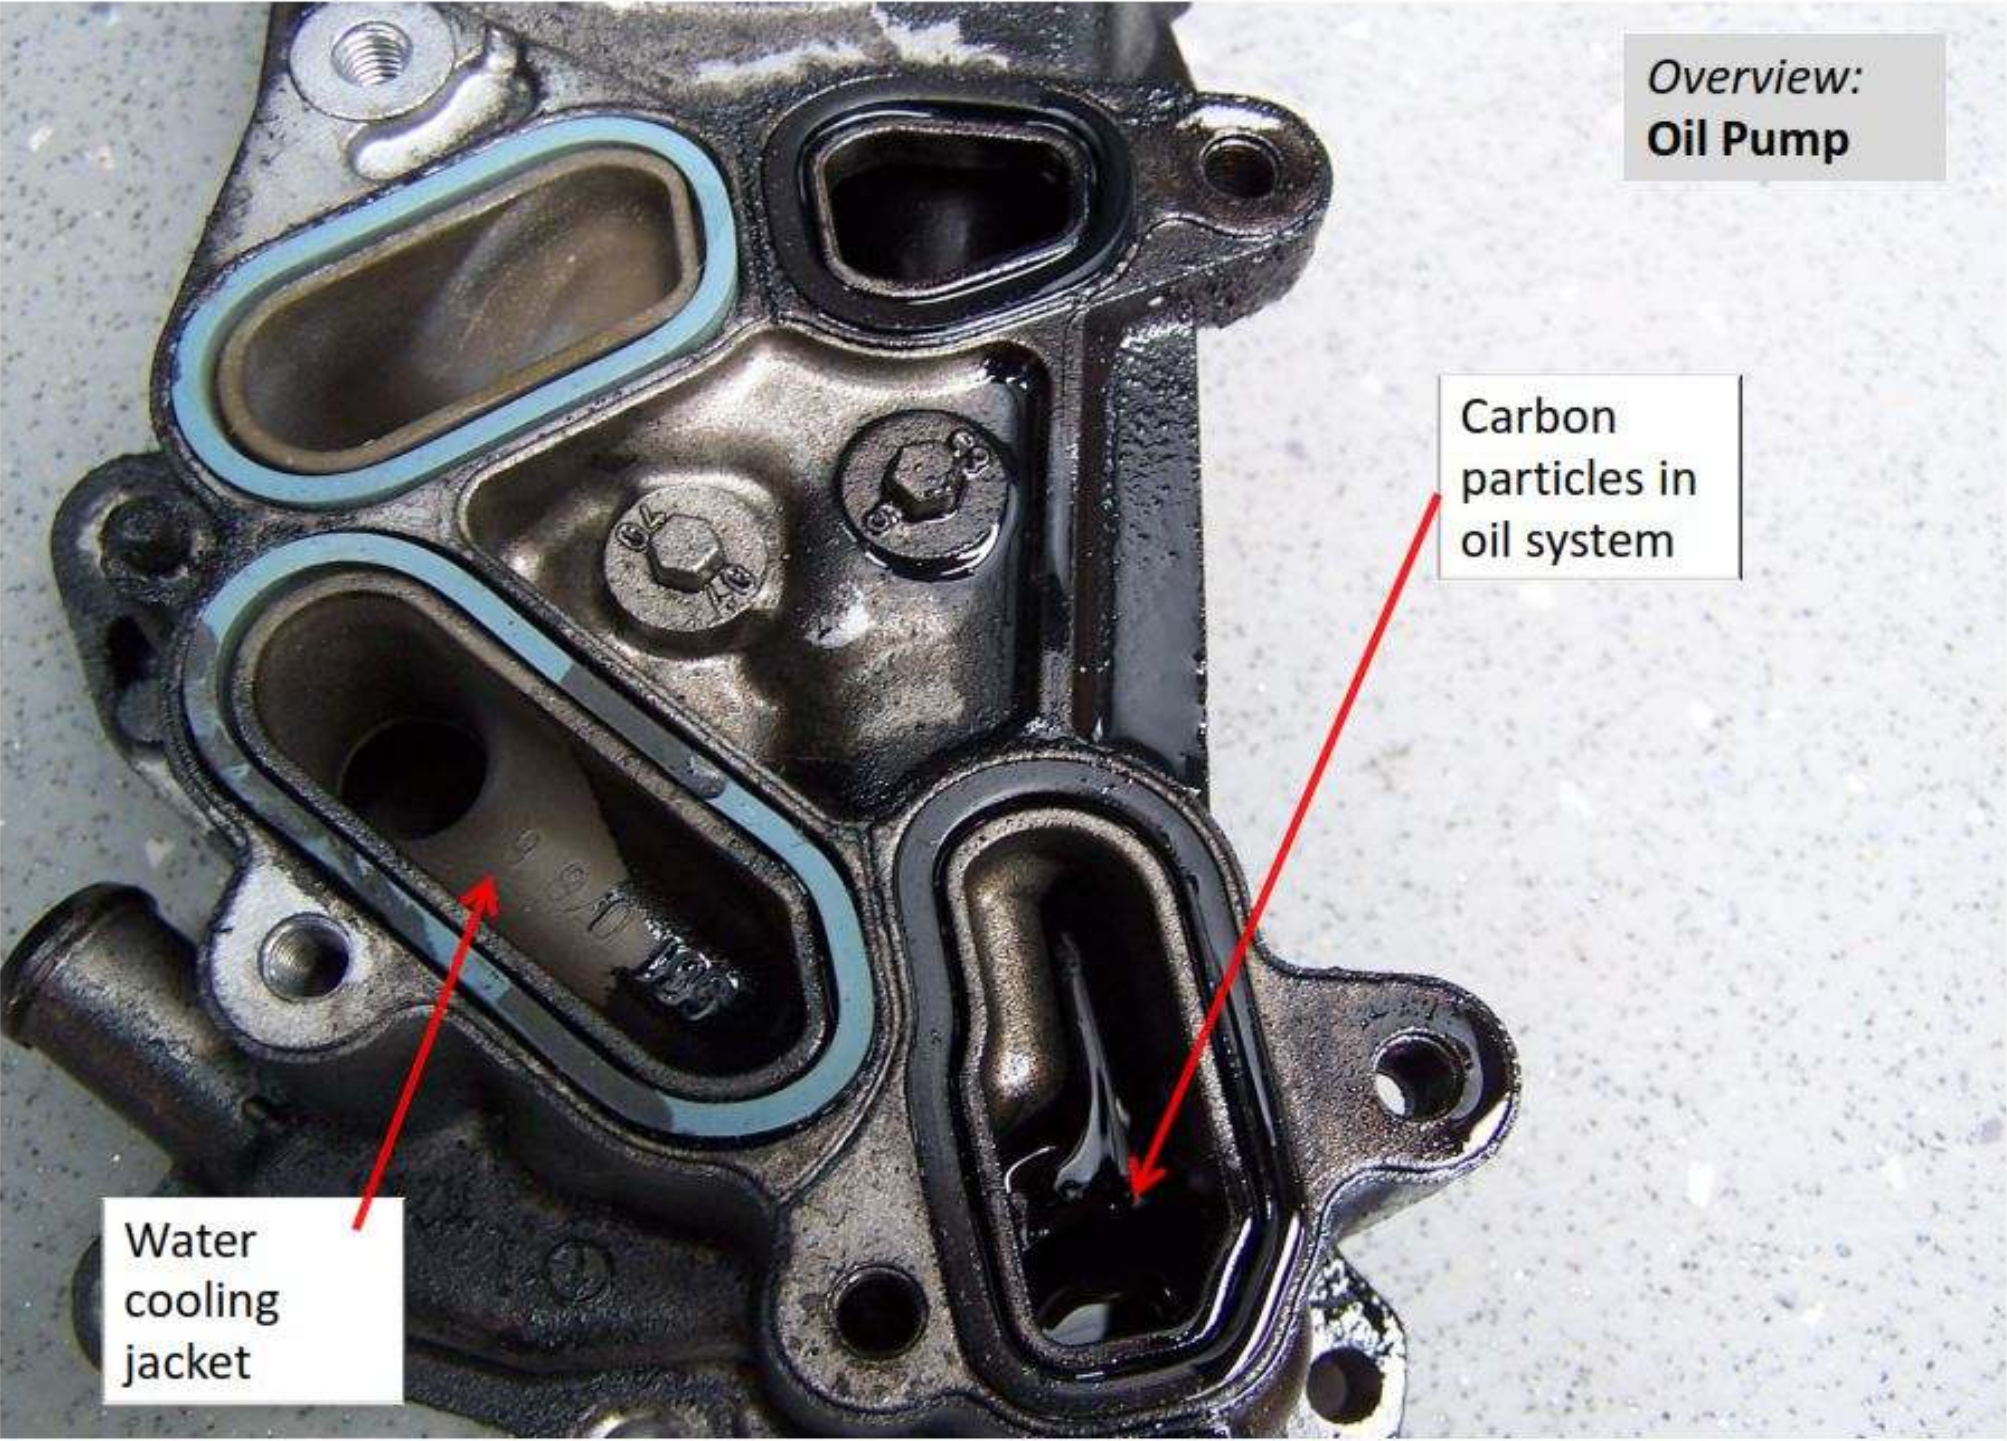
Overview:
Oil Pump

Carbon
particles in
oil system

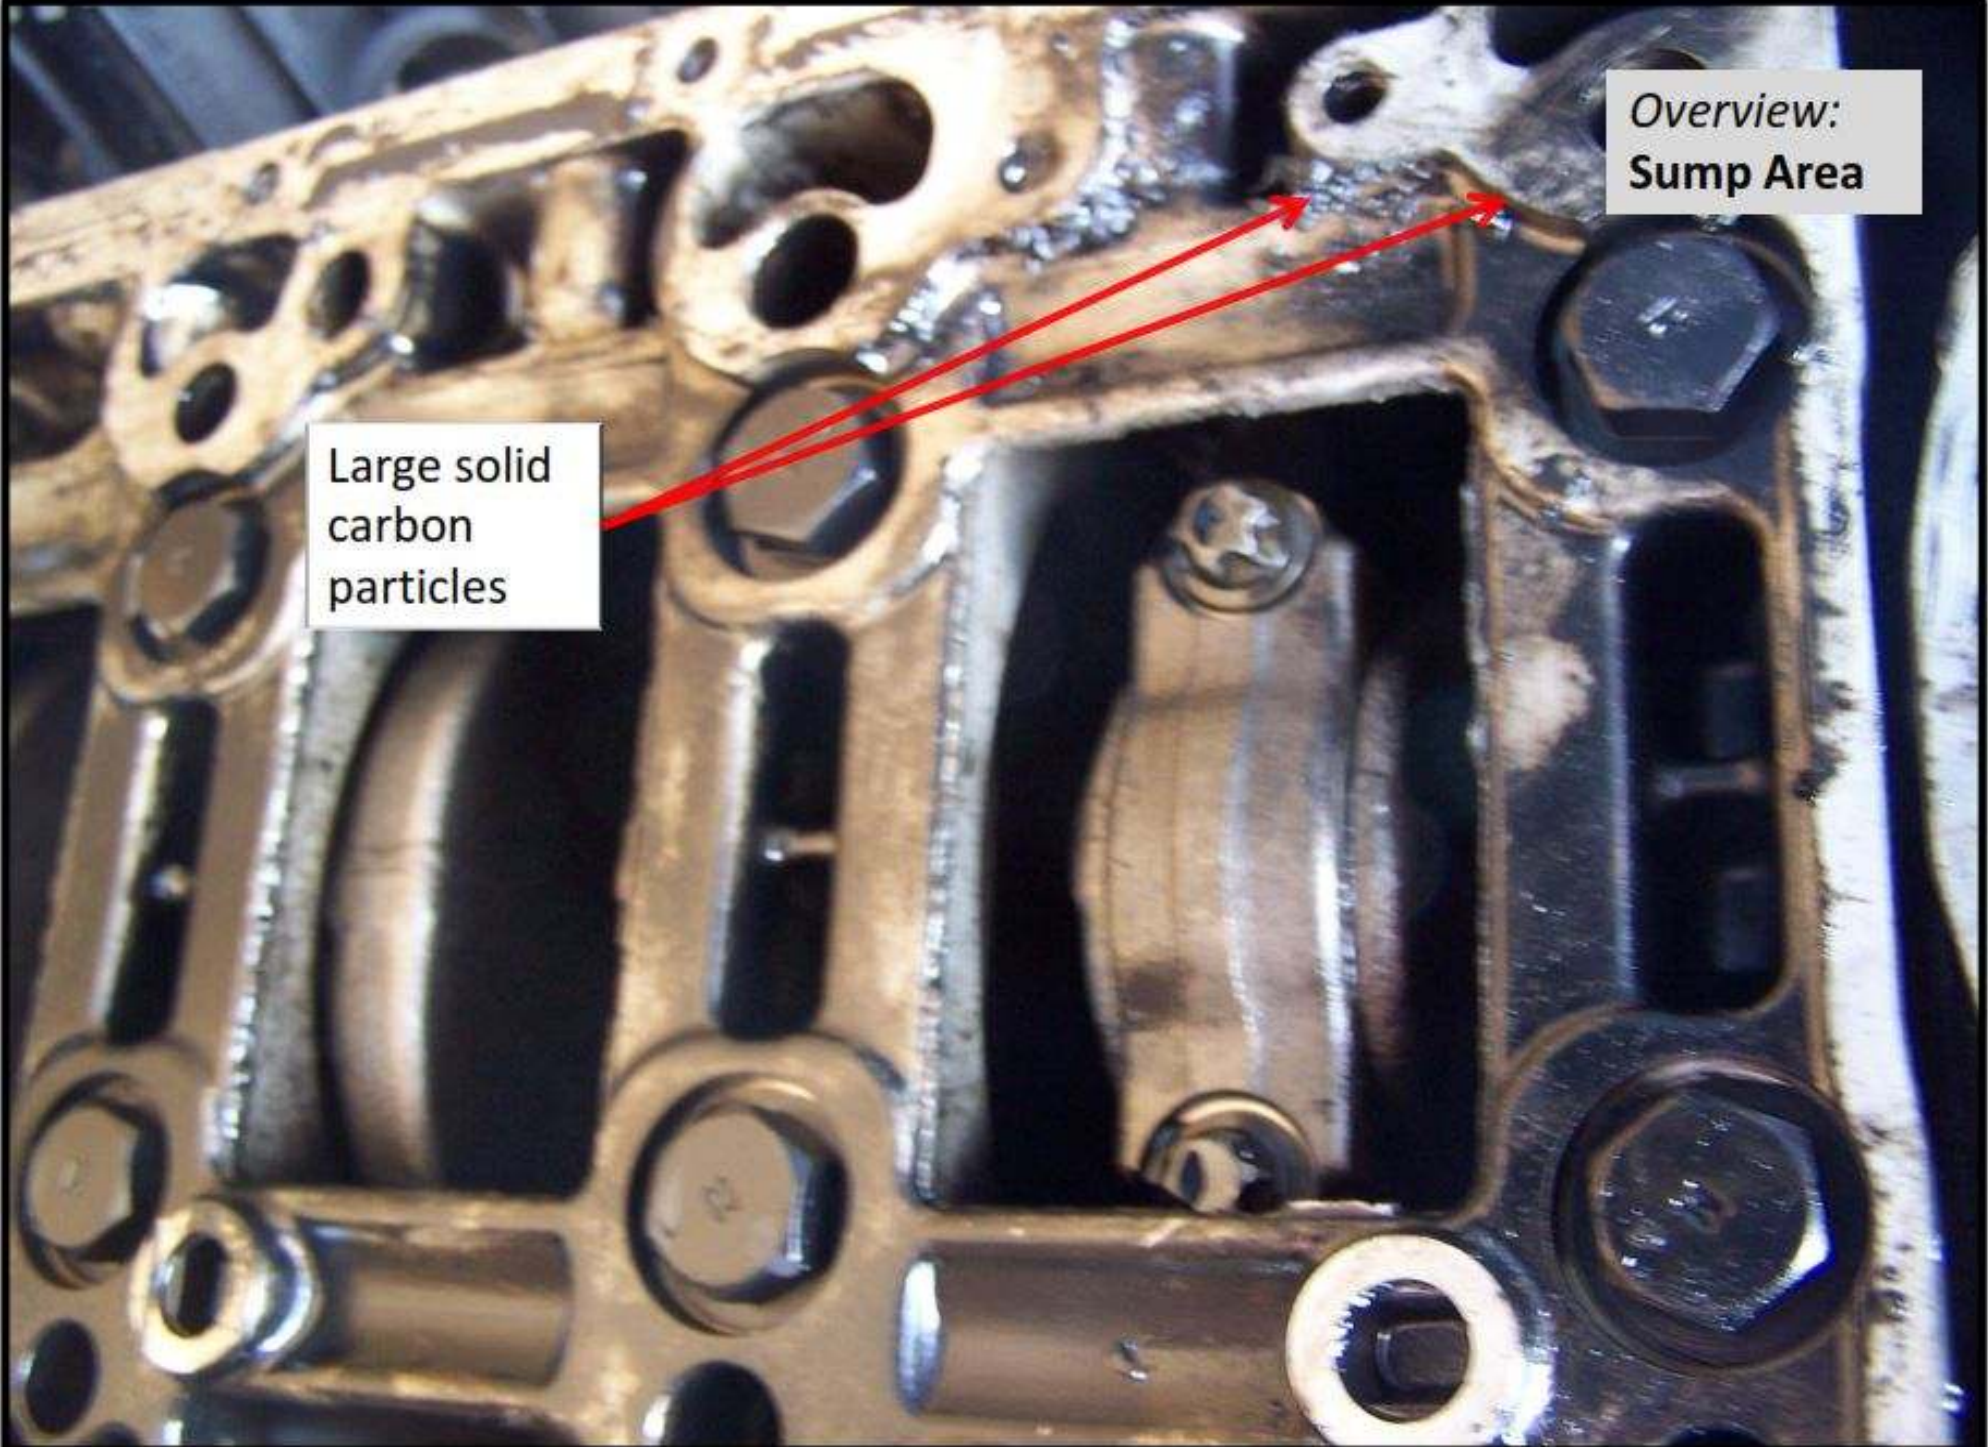
Overview:
Sump Area

These solid parts get pumped directly to the turbo, causing extensive damage to the bearing system, ultimately destroying the turbo

Large solid
carbon
particles

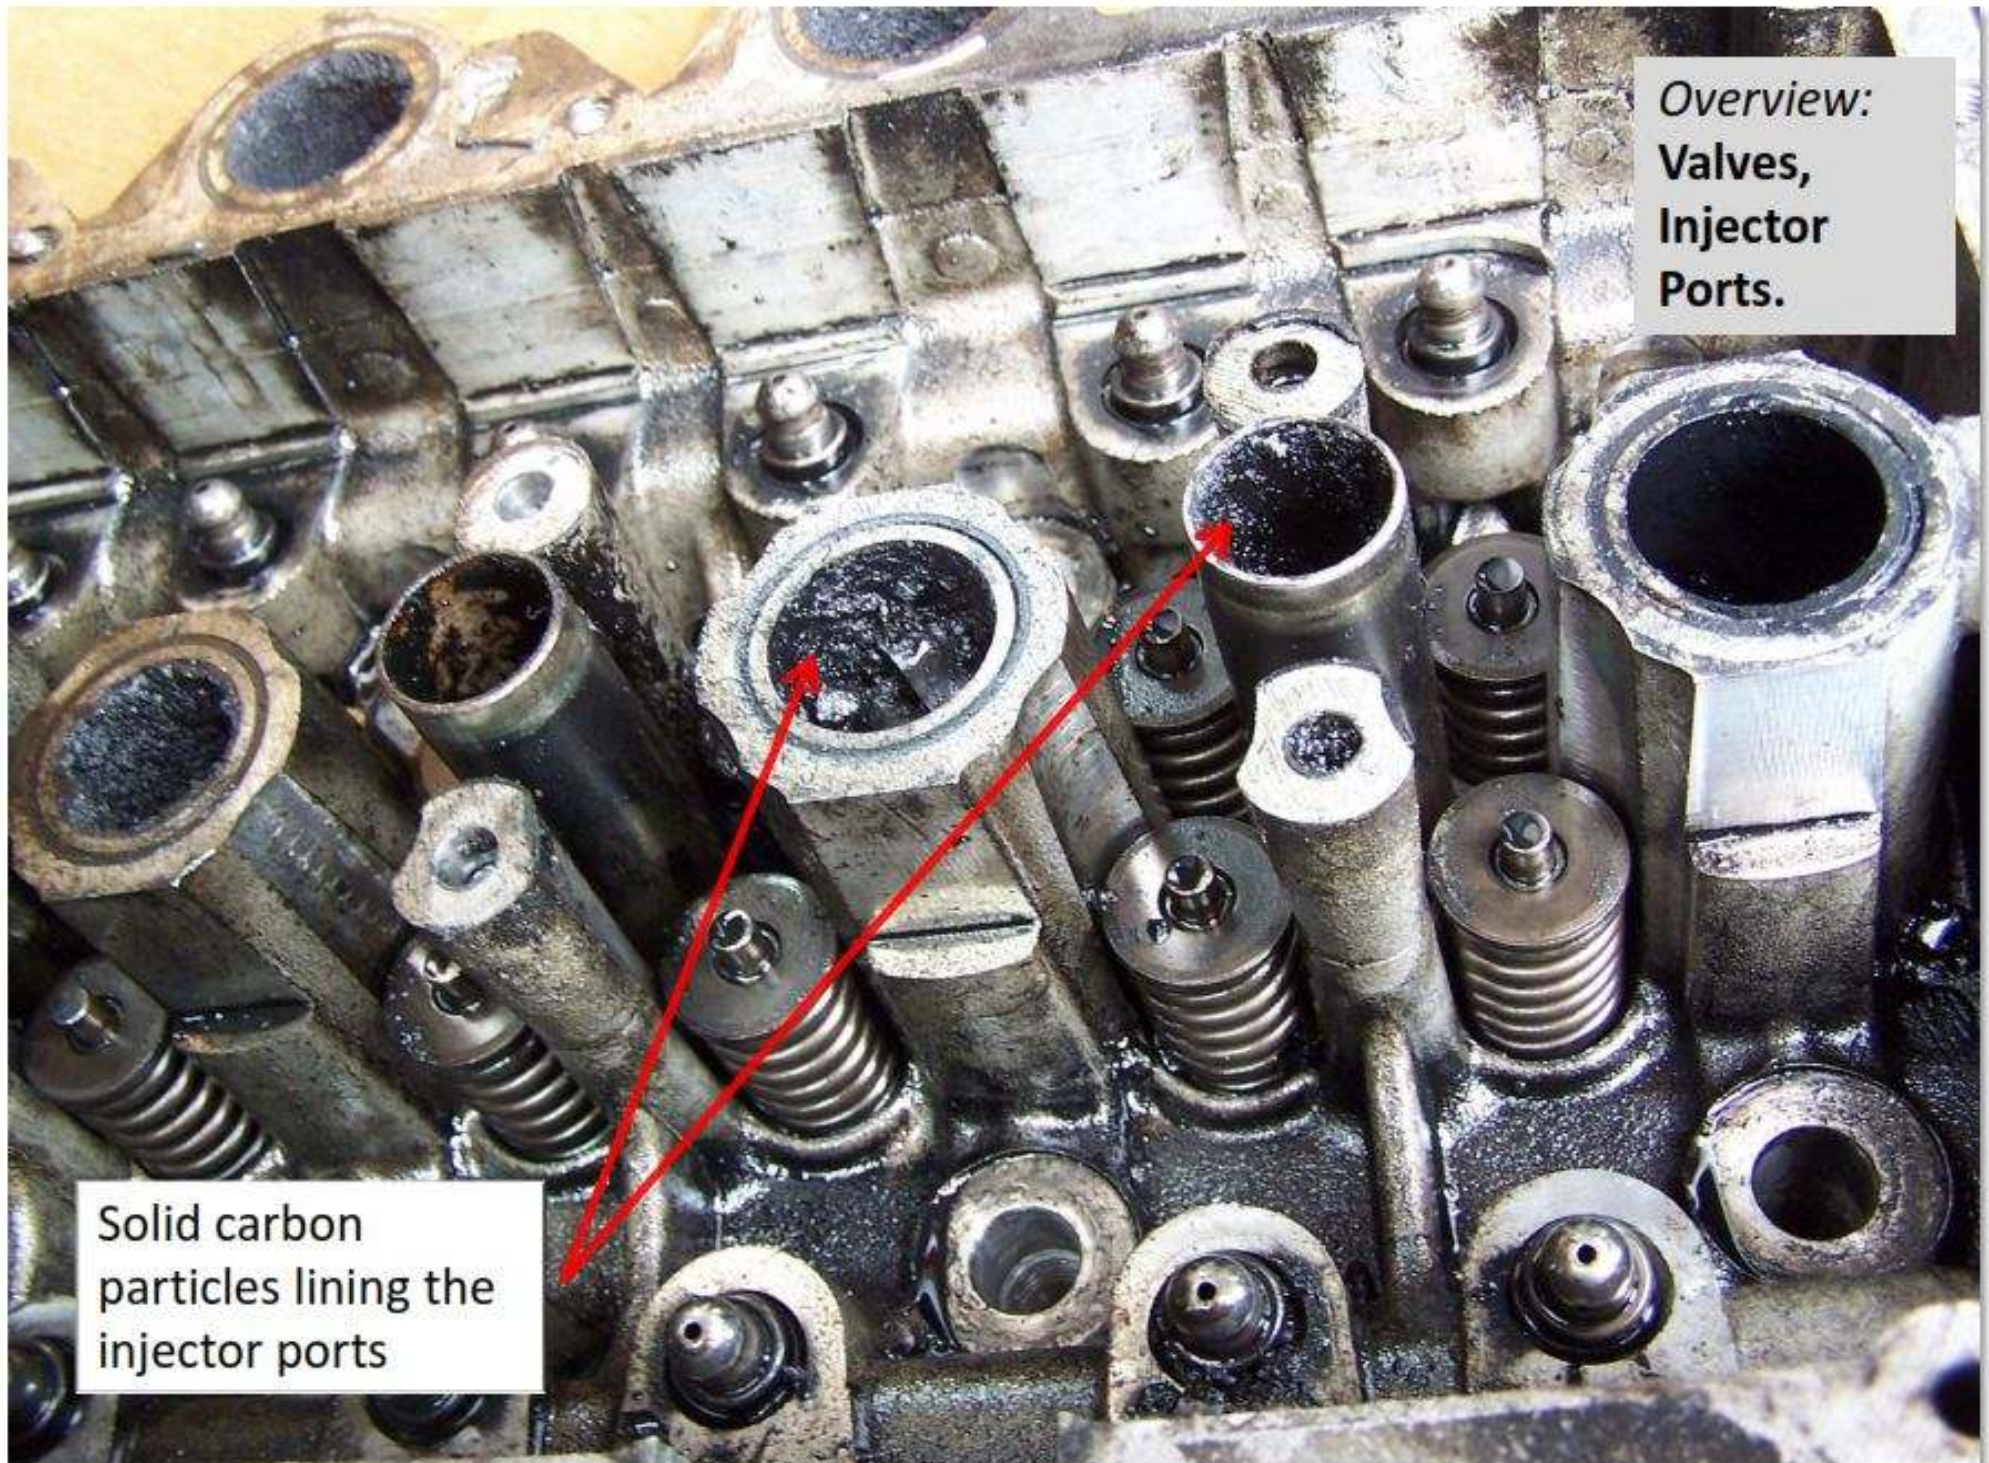
Overview:
**Valves,
Injector
Ports.**

Solid carbon
particles lining the
injector ports

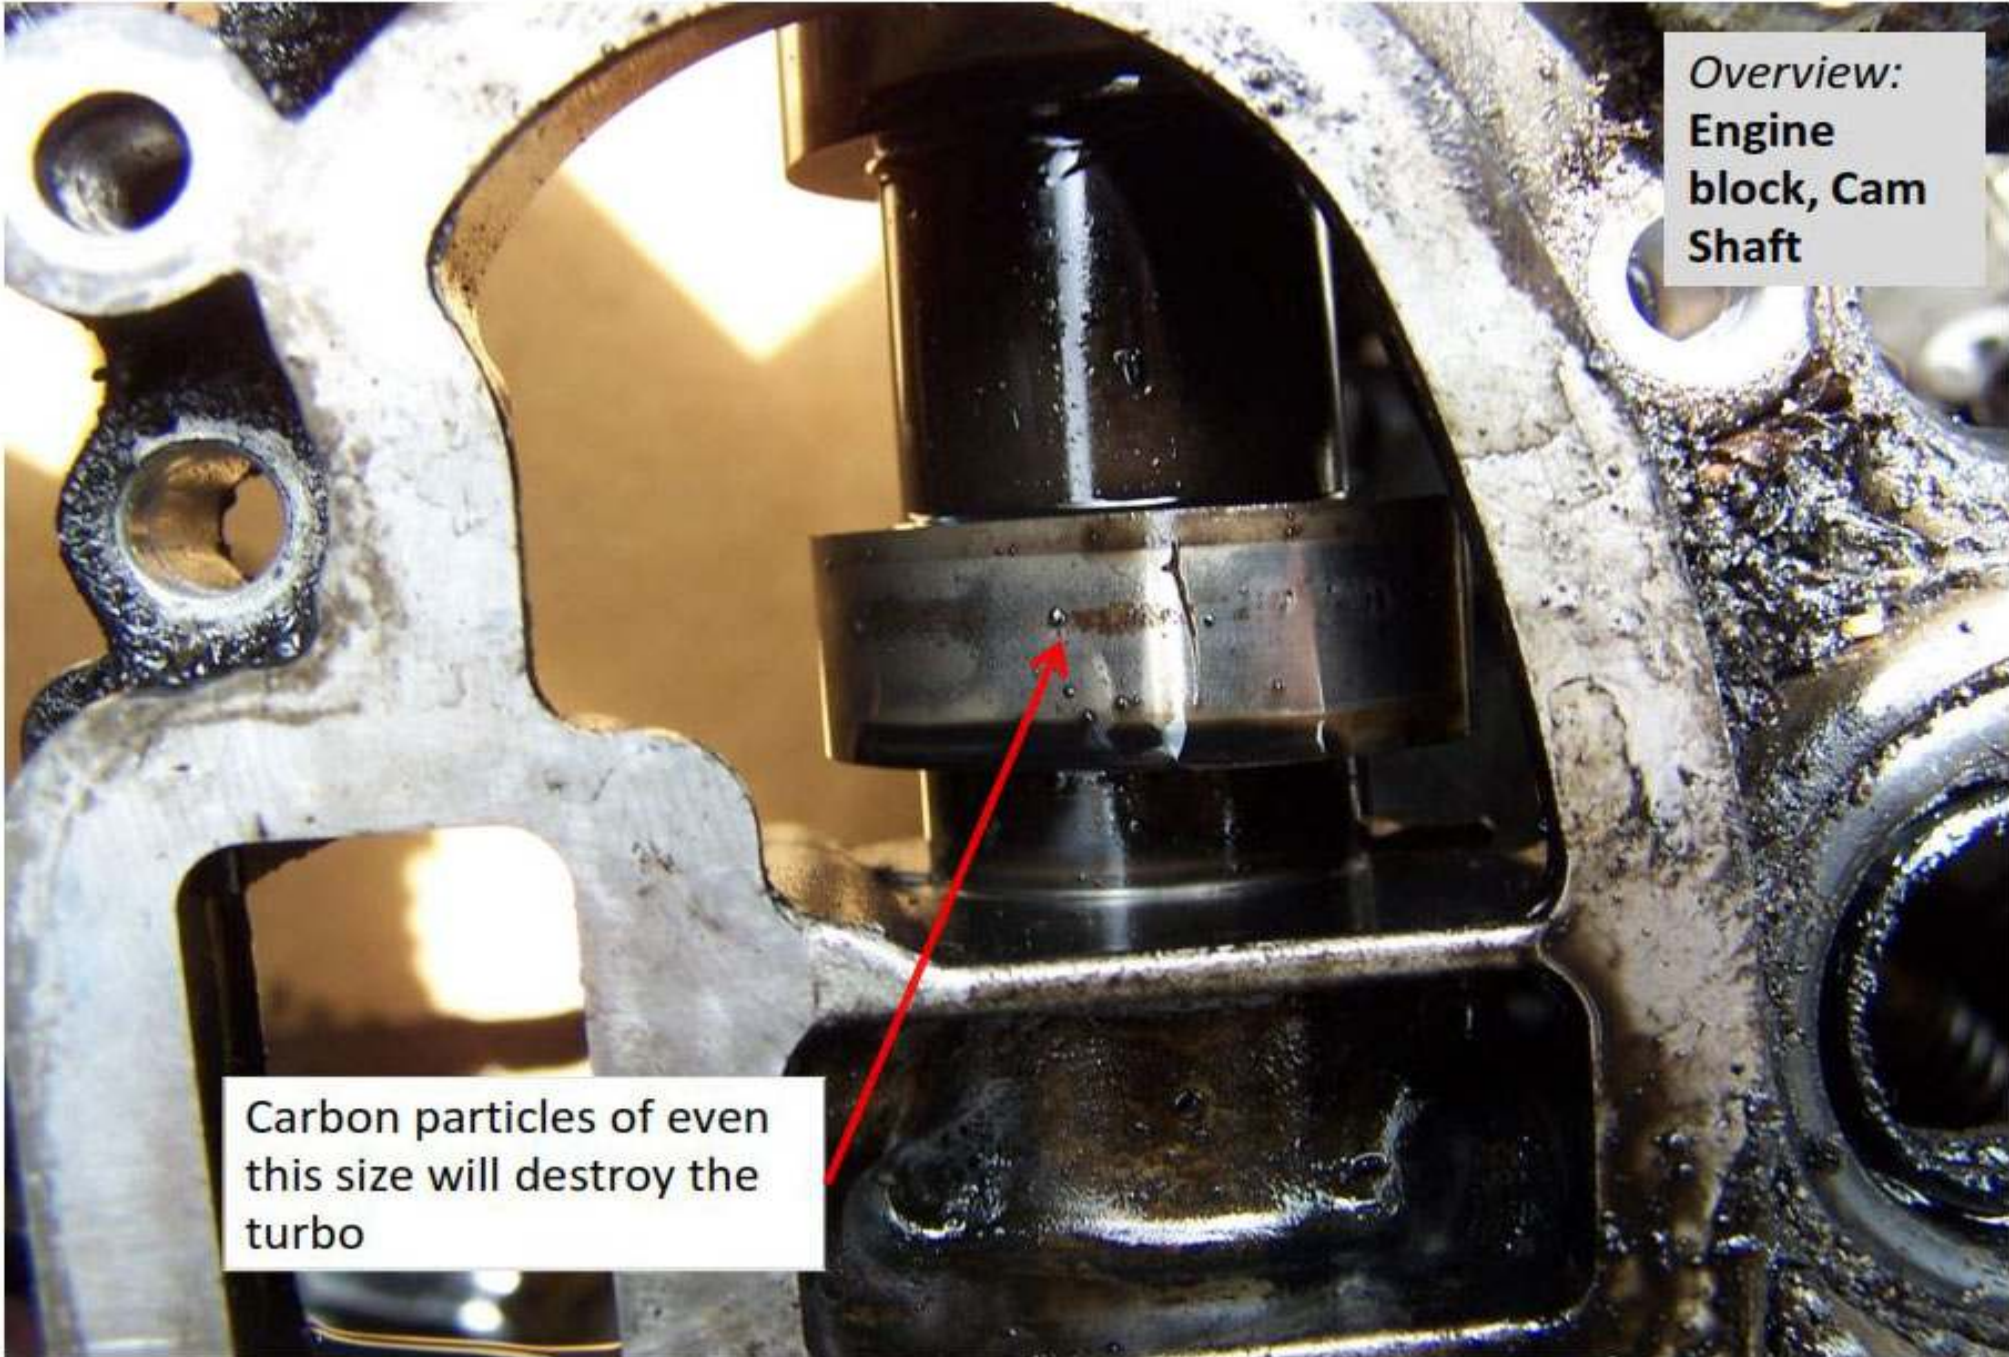
Overview:
Engine
block, Cam
Shaft

Carbon particles of even
this size will destroy the
turbo

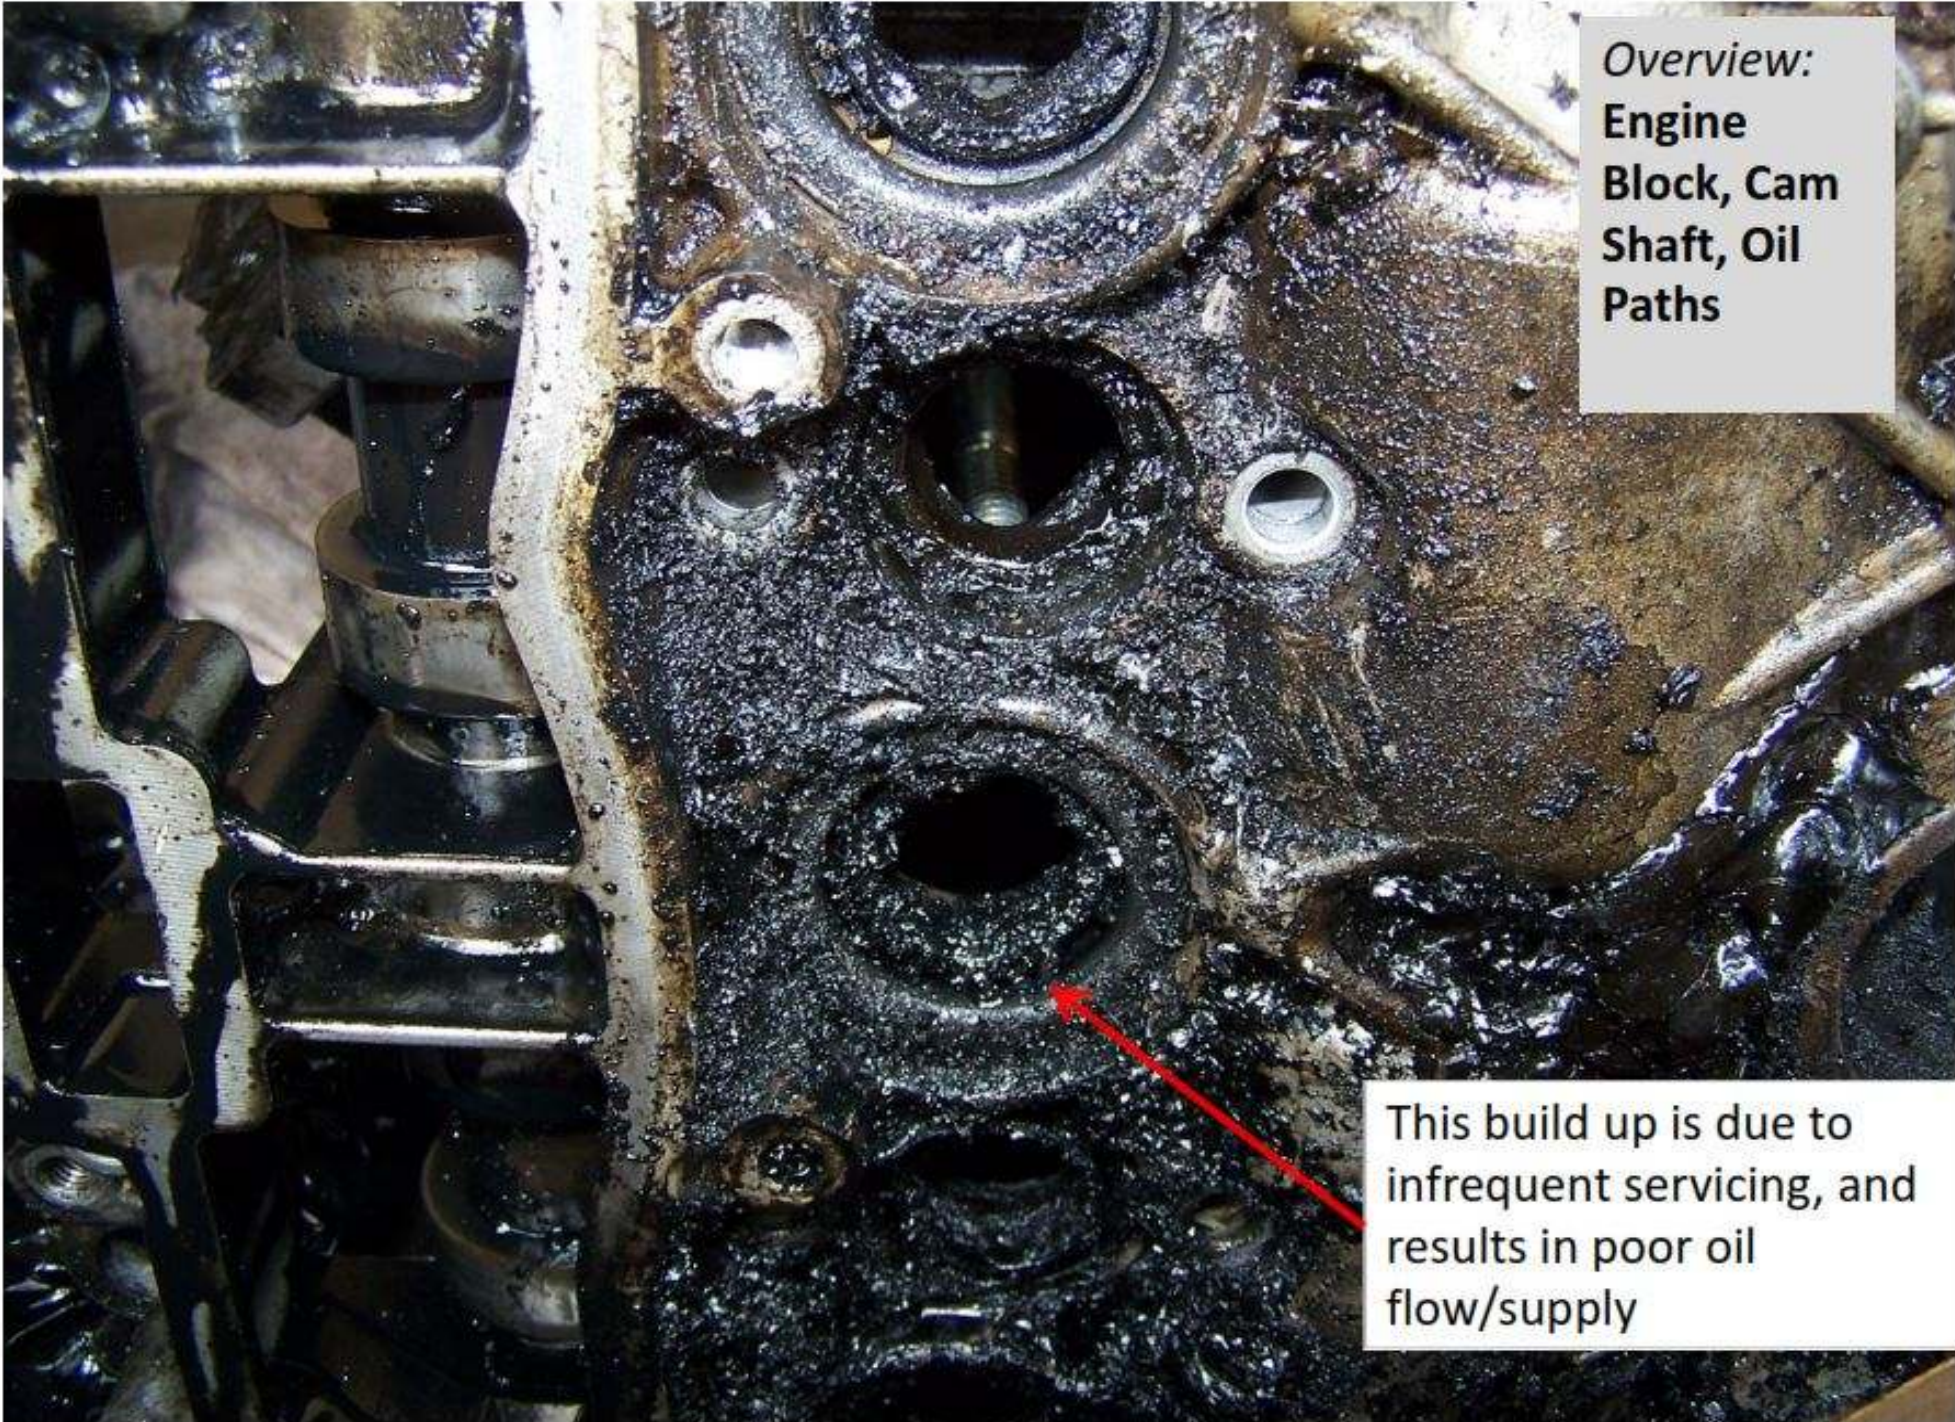
Overview:
**Engine Block, Cam
Shaft, Oil Paths**

**Carbon particles initially build up
in the oil paths and eventually
break off and move into the
sump area**

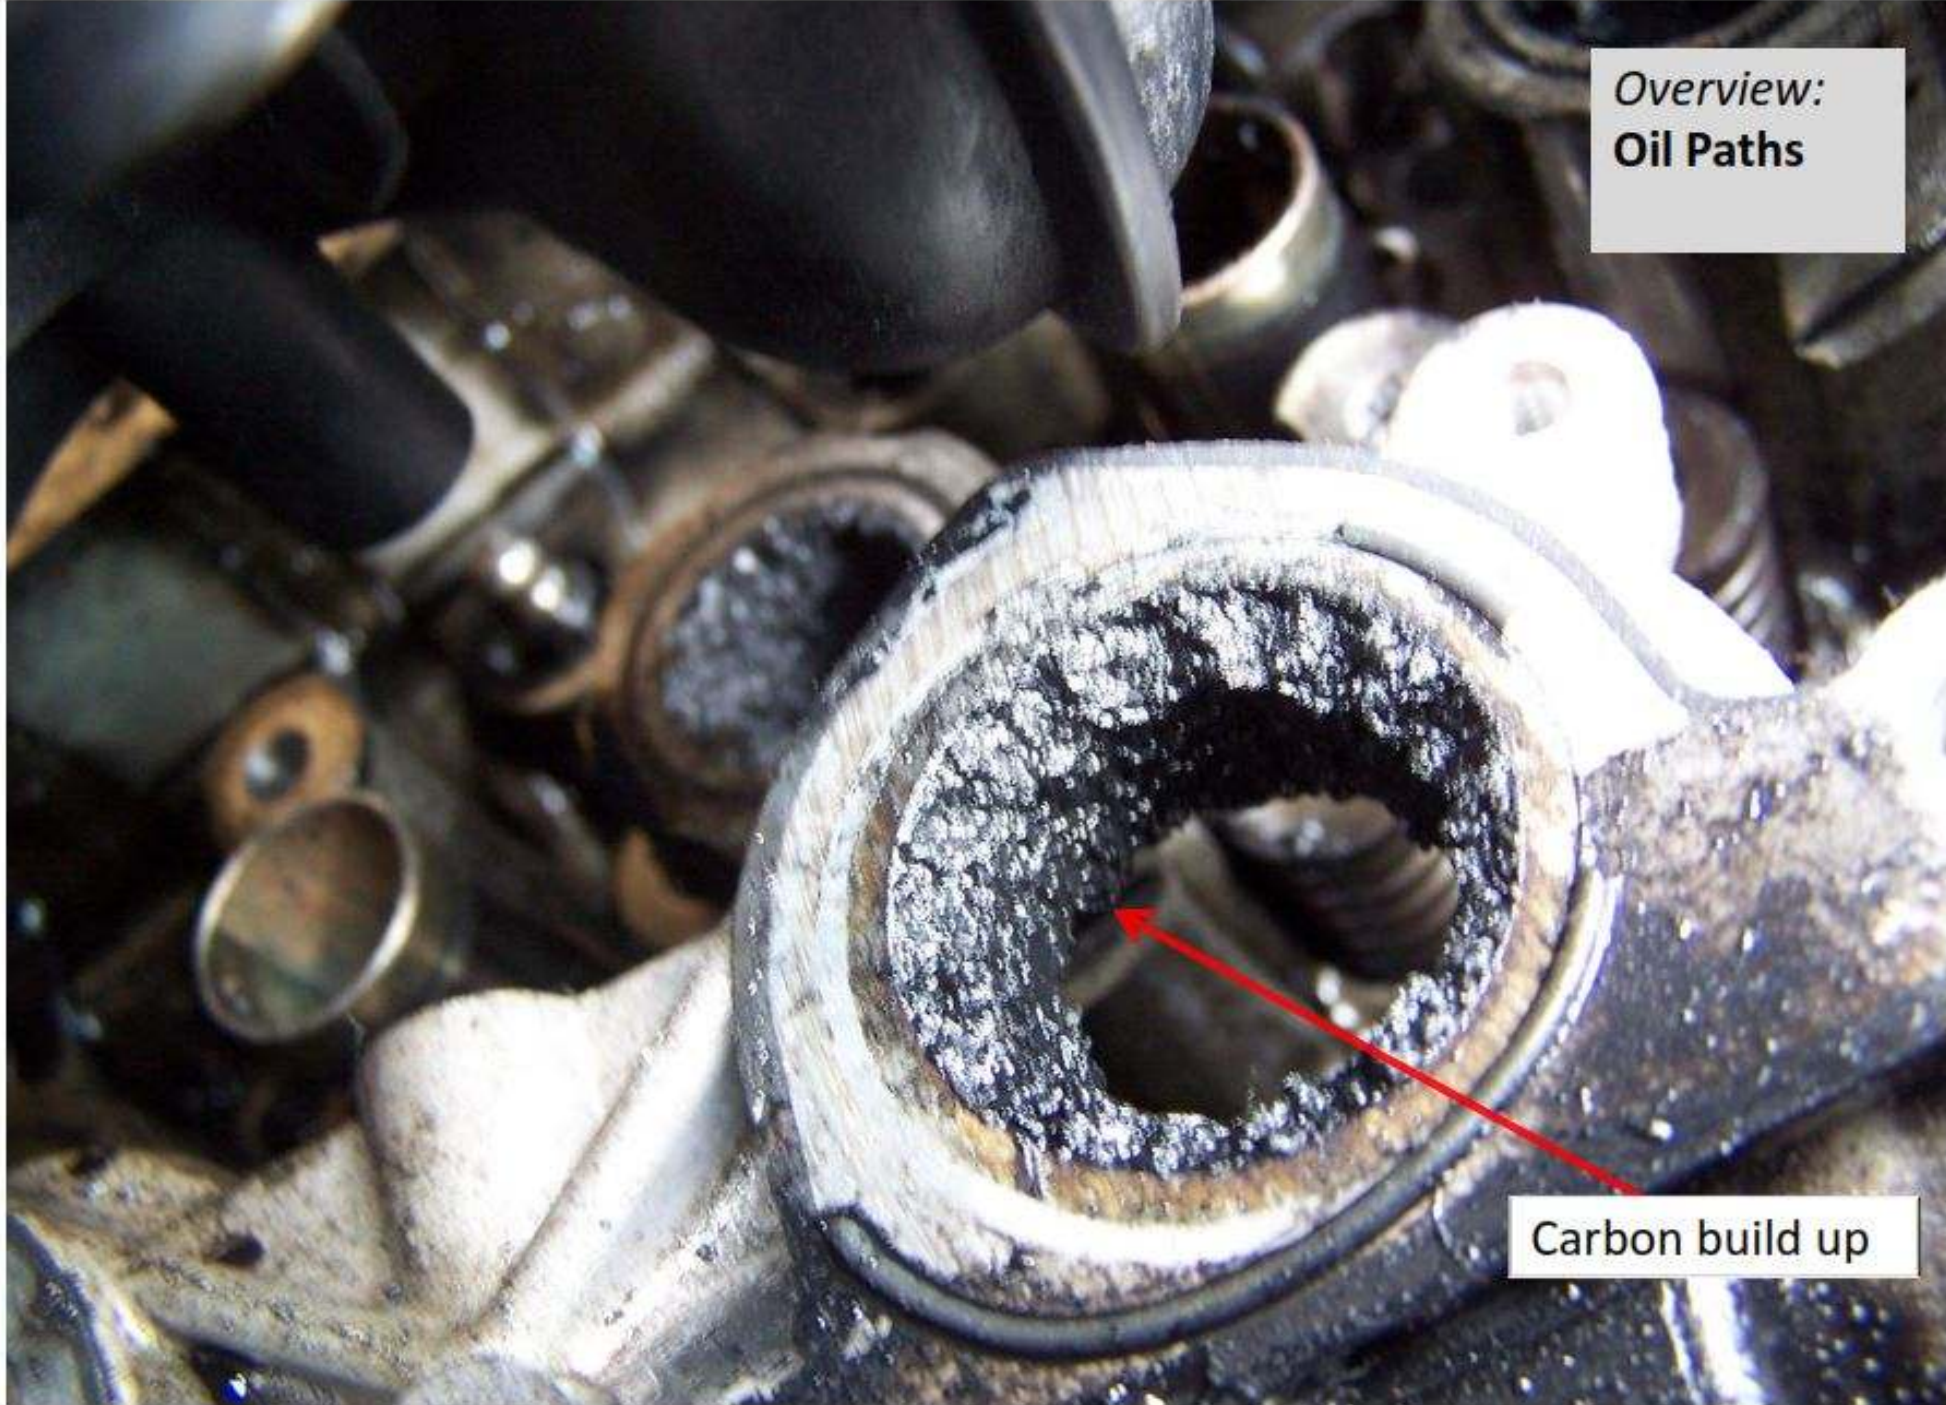
Overview:
Engine
Block, Cam
Shaft, Oil
Paths

This build up is due to infrequent servicing, and results in poor oil flow/supply

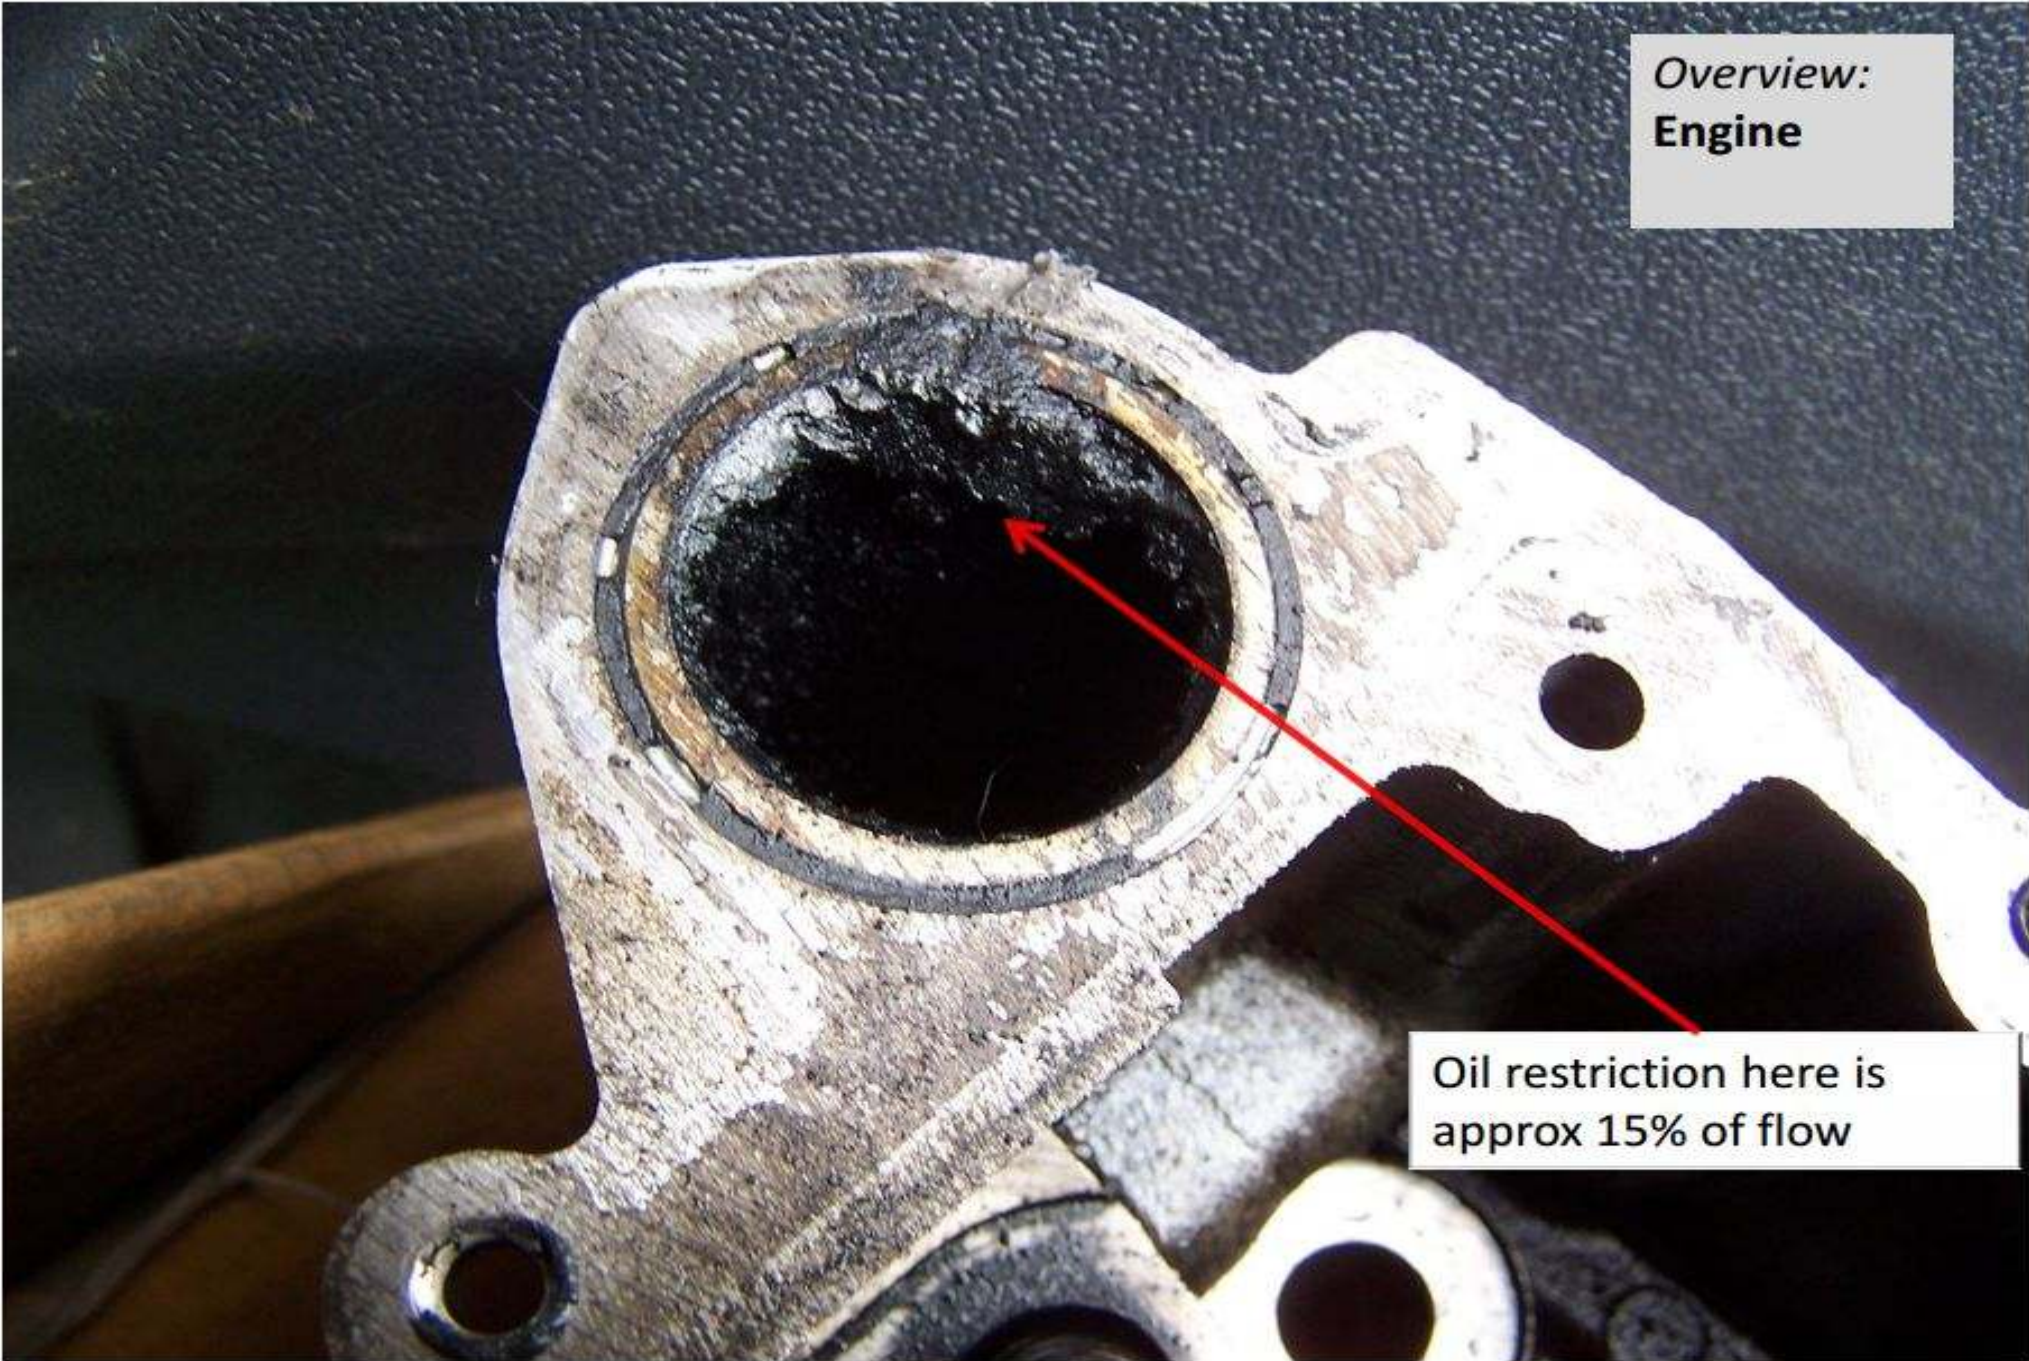
Overview:
Oil Paths

Carbon build up

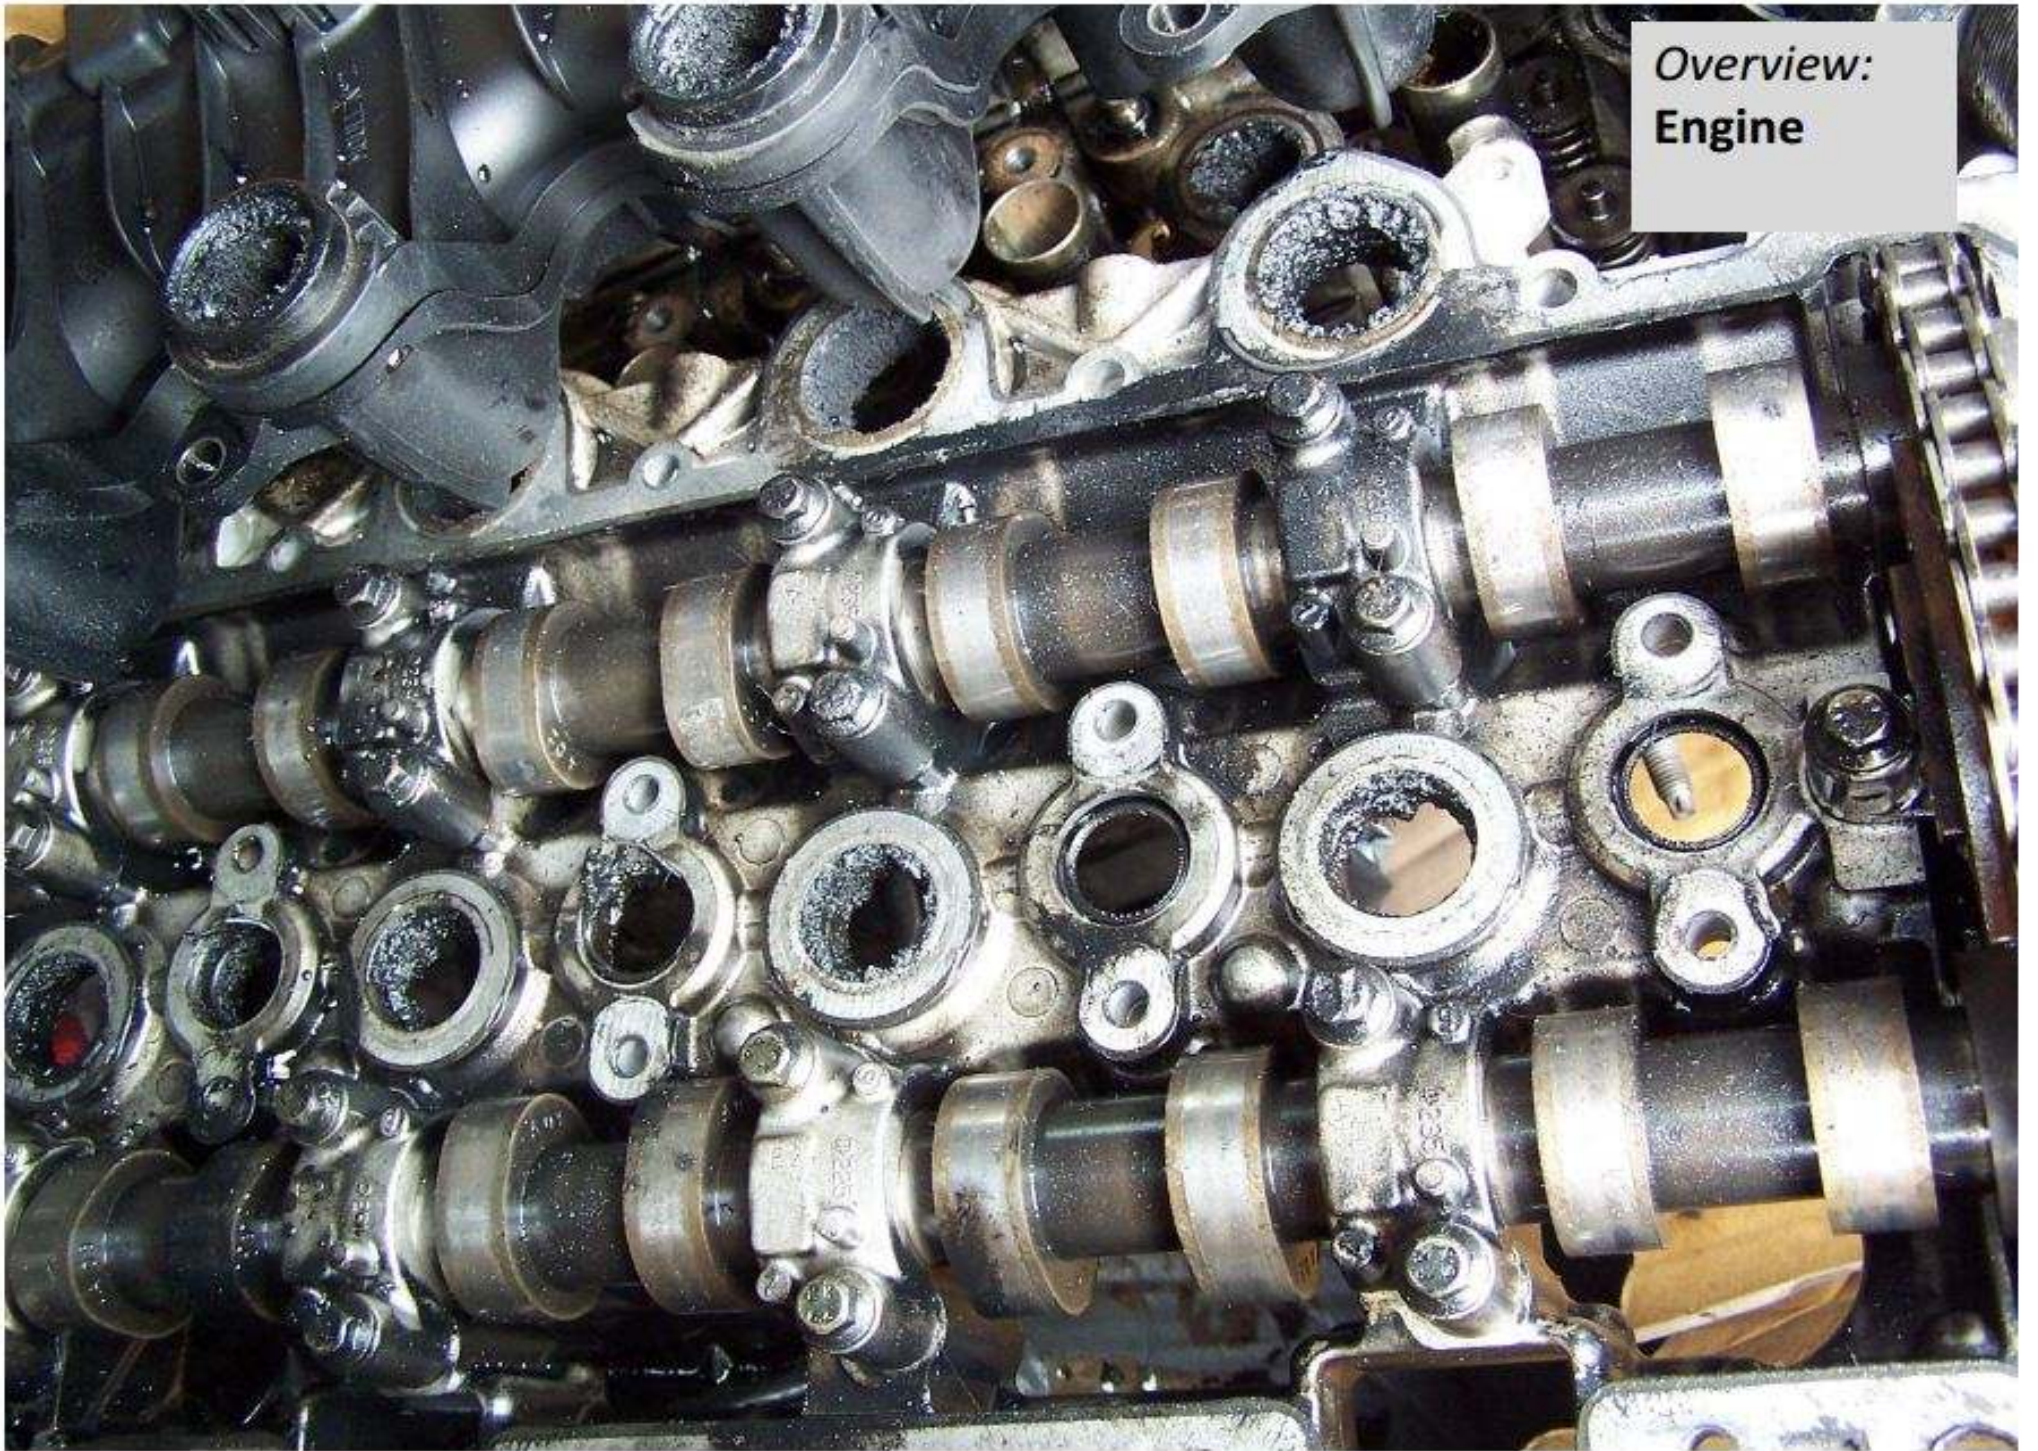
Overview:
Engine

Oil restriction here is approx 15% of flow
