1.6 HDi PSA Engine DV6TED4

**Evidence of carbon
build up in a 1.6 HDi
PSA Group engine
leading to total
turbocharger failure**

Case Study

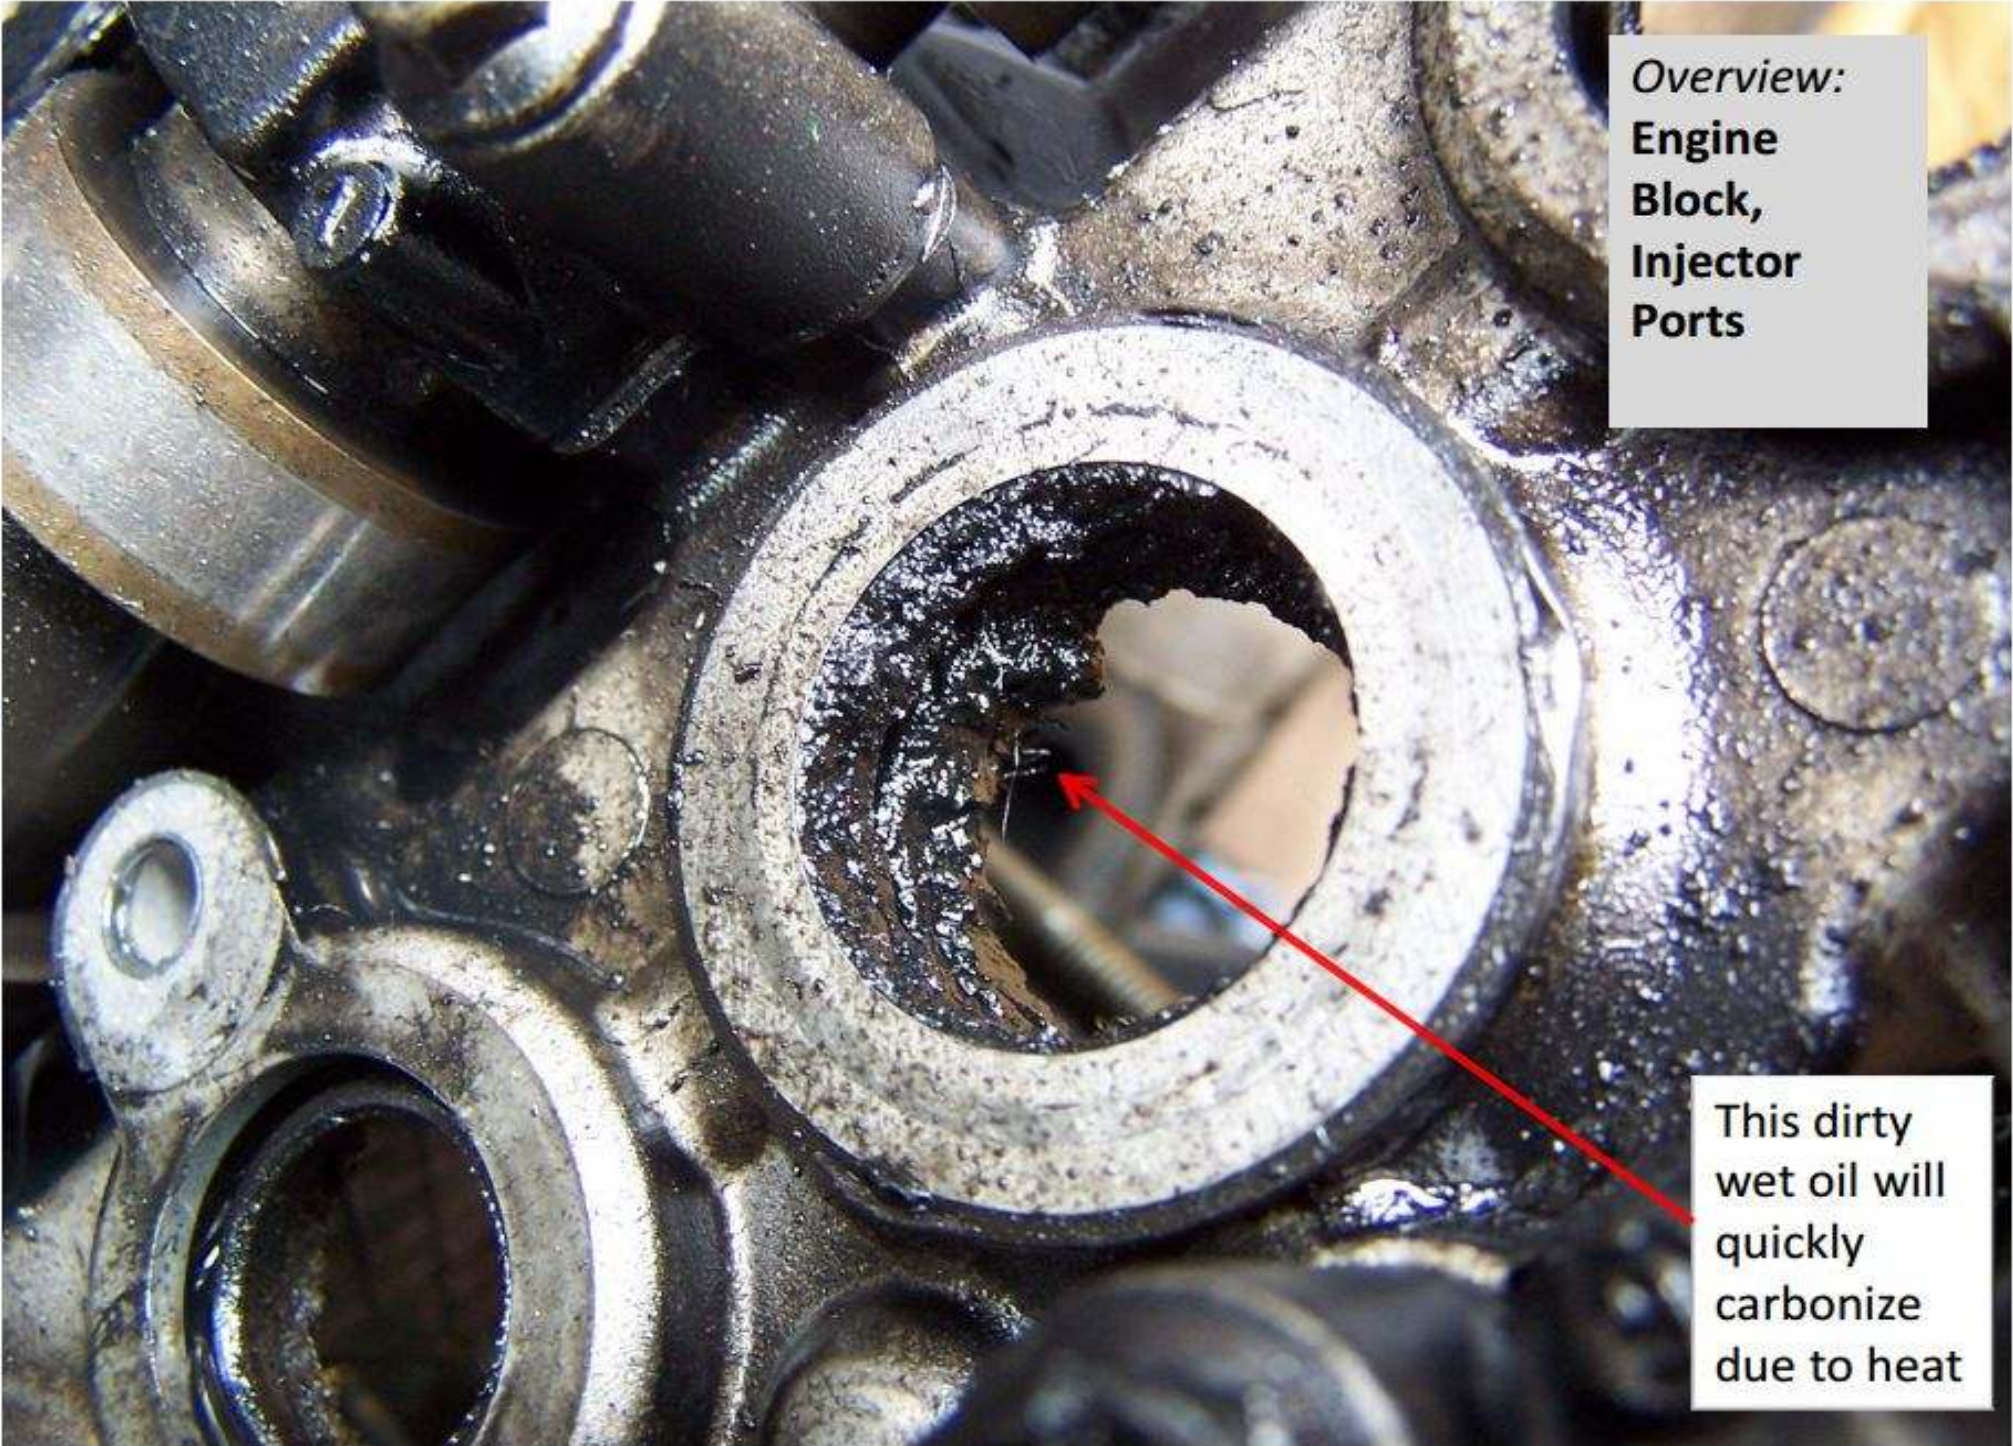
**Overview:
Engine
Block,
Injector
Ports**

This dirty
wet oil will
quickly
carbonize
due to heat

It is clear that the carbon remains even after 2 flushing procedures.....

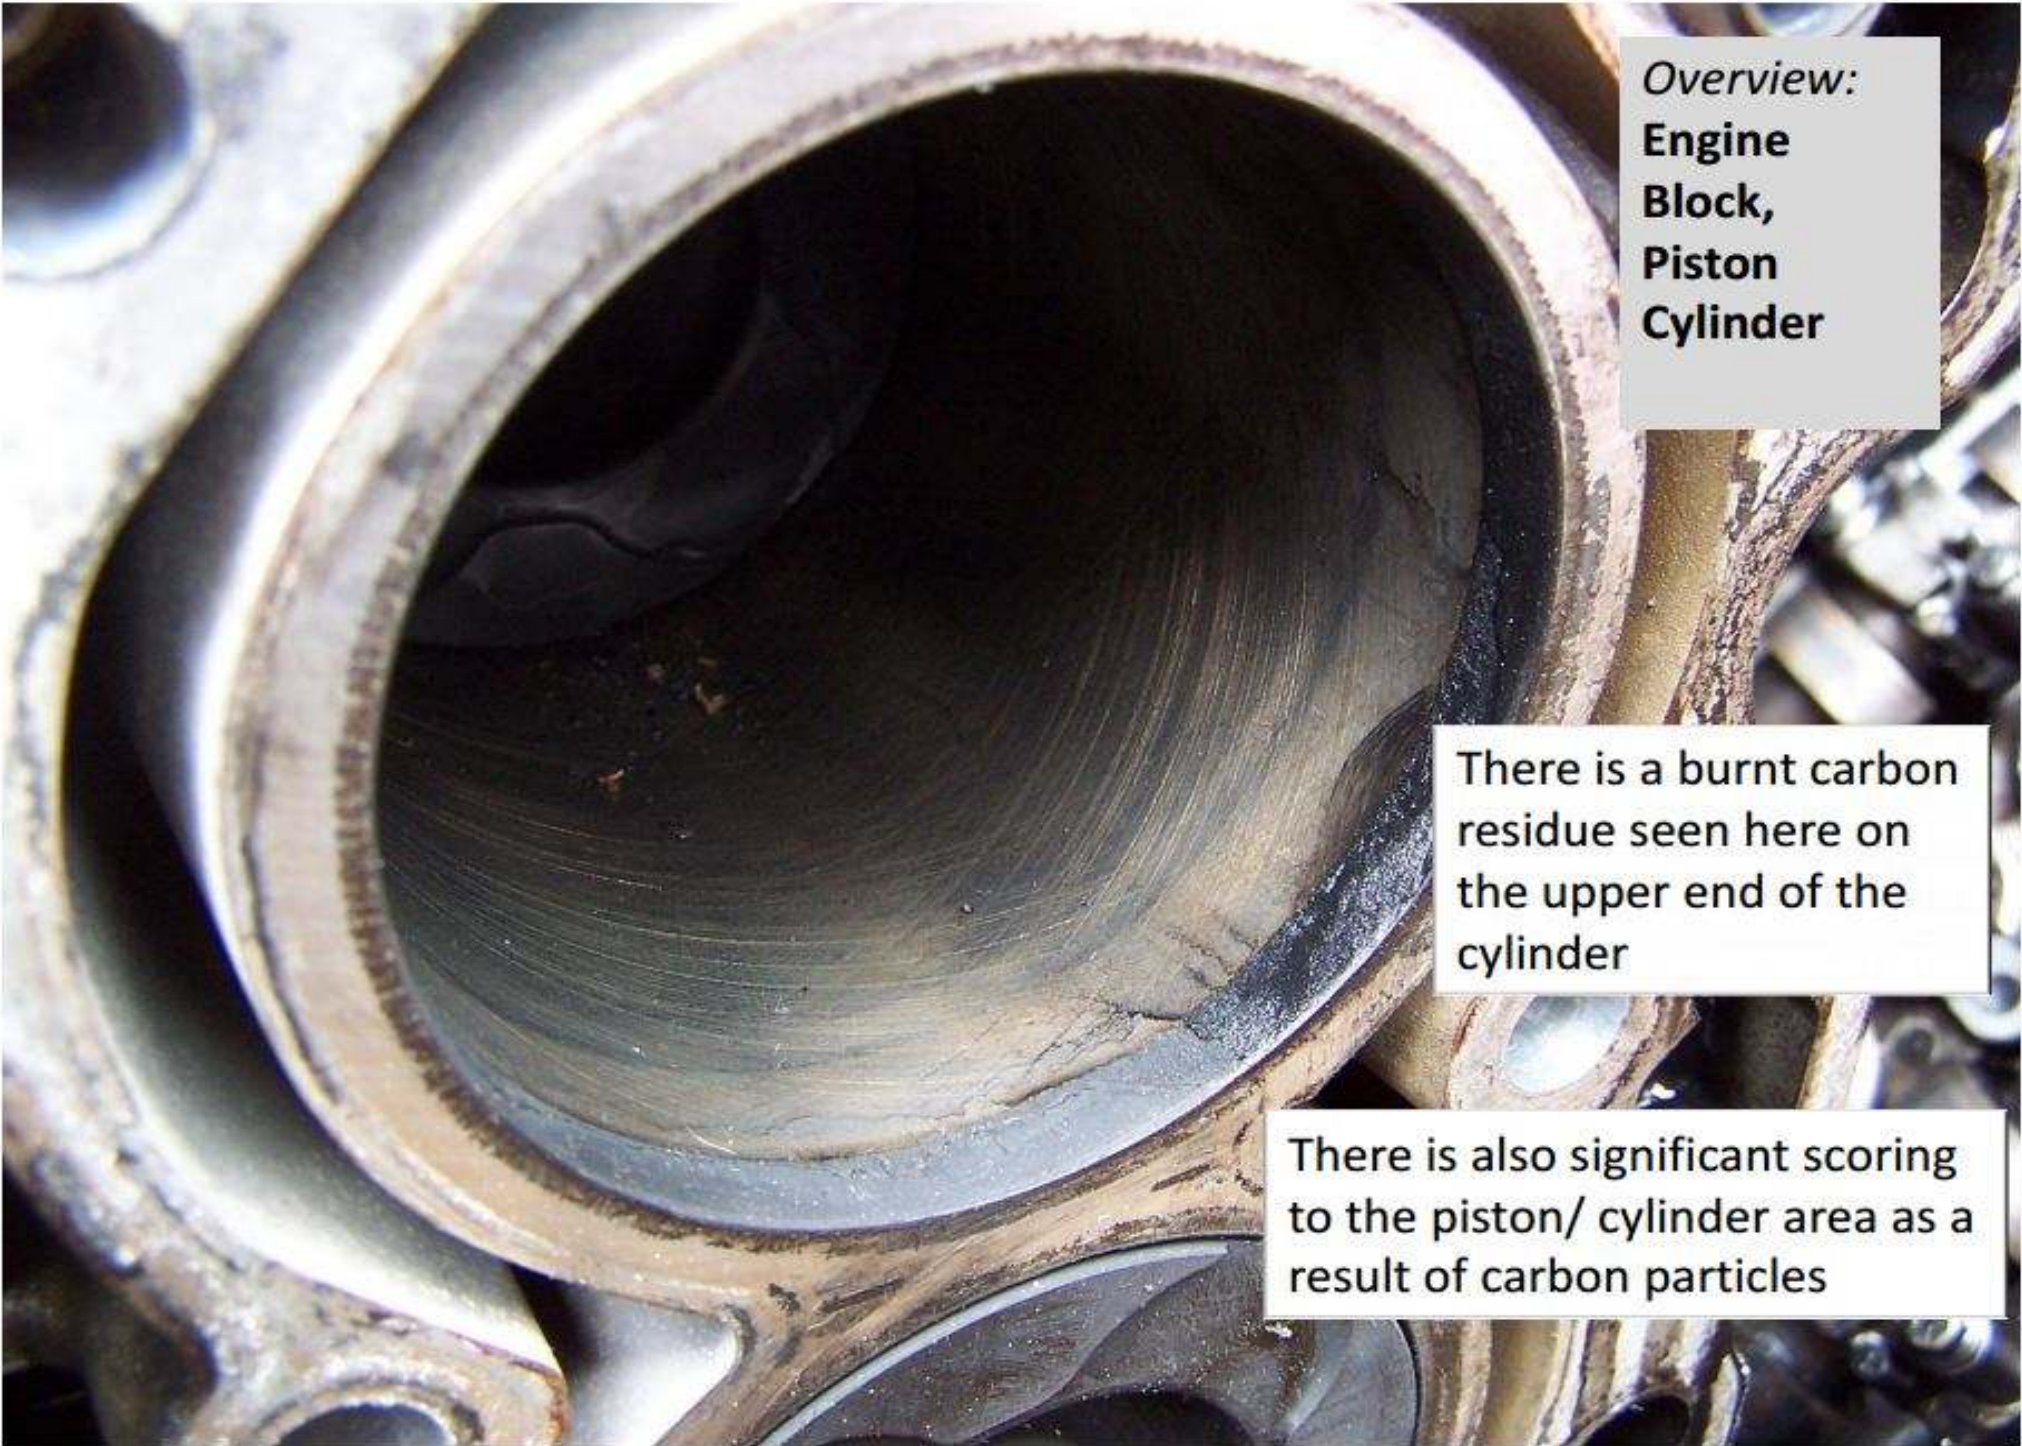
Overview:
**Engine
Block,
Piston
Cylinder**

There is a burnt carbon residue seen here on the upper end of the cylinder

There is also significant scoring to the piston/ cylinder area as a result of carbon particles

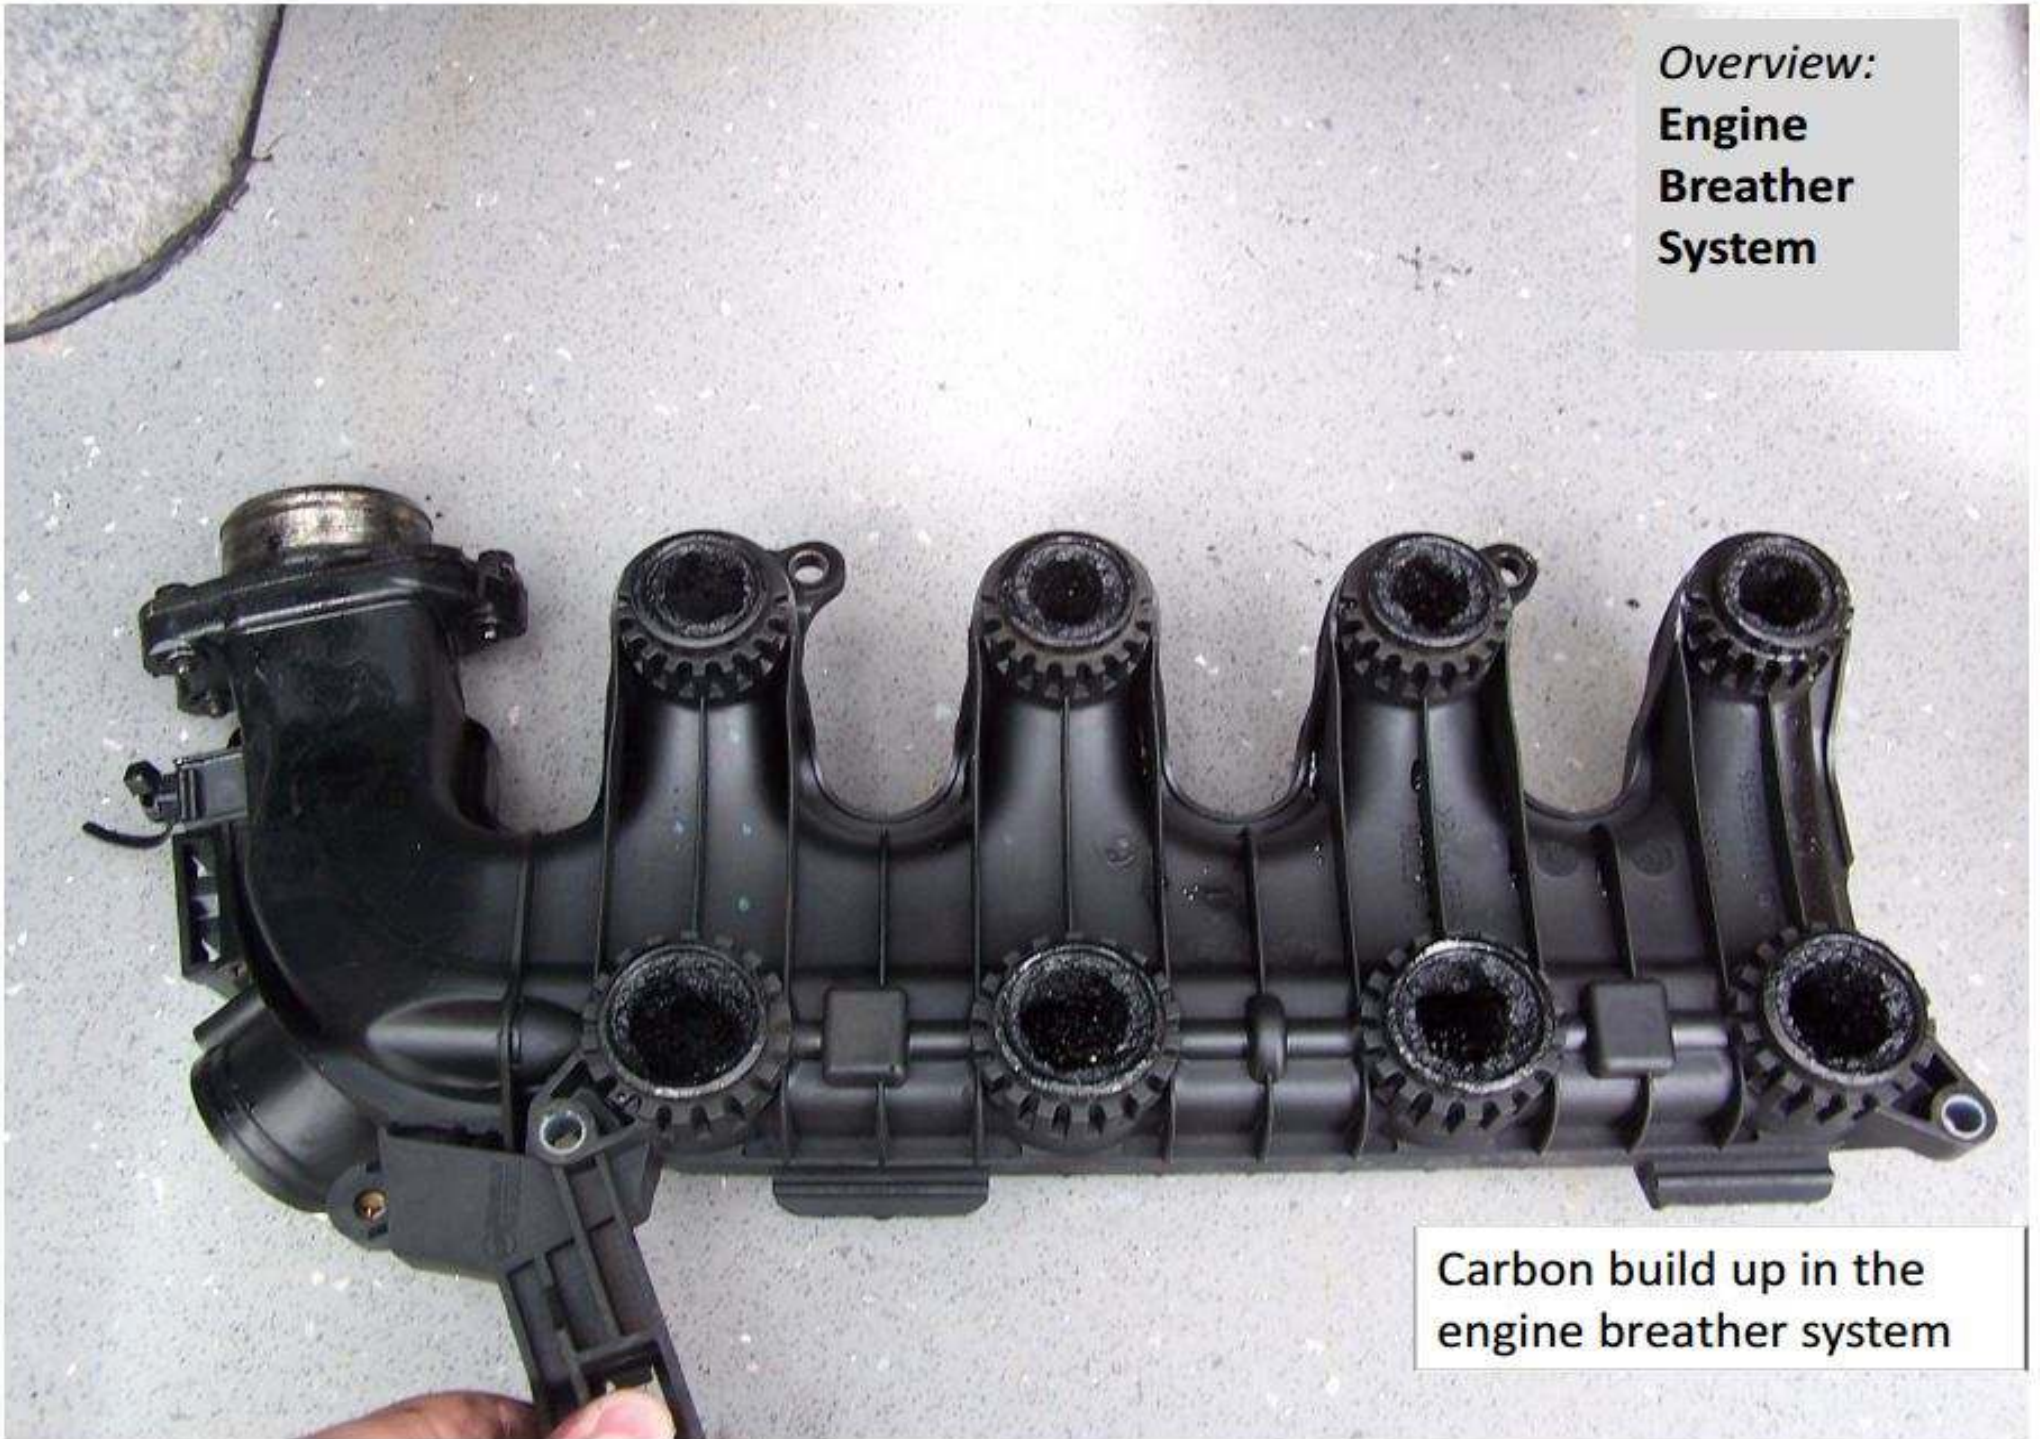
Overview:
**Engine
Breather
System**

Carbon build up in the engine breather system

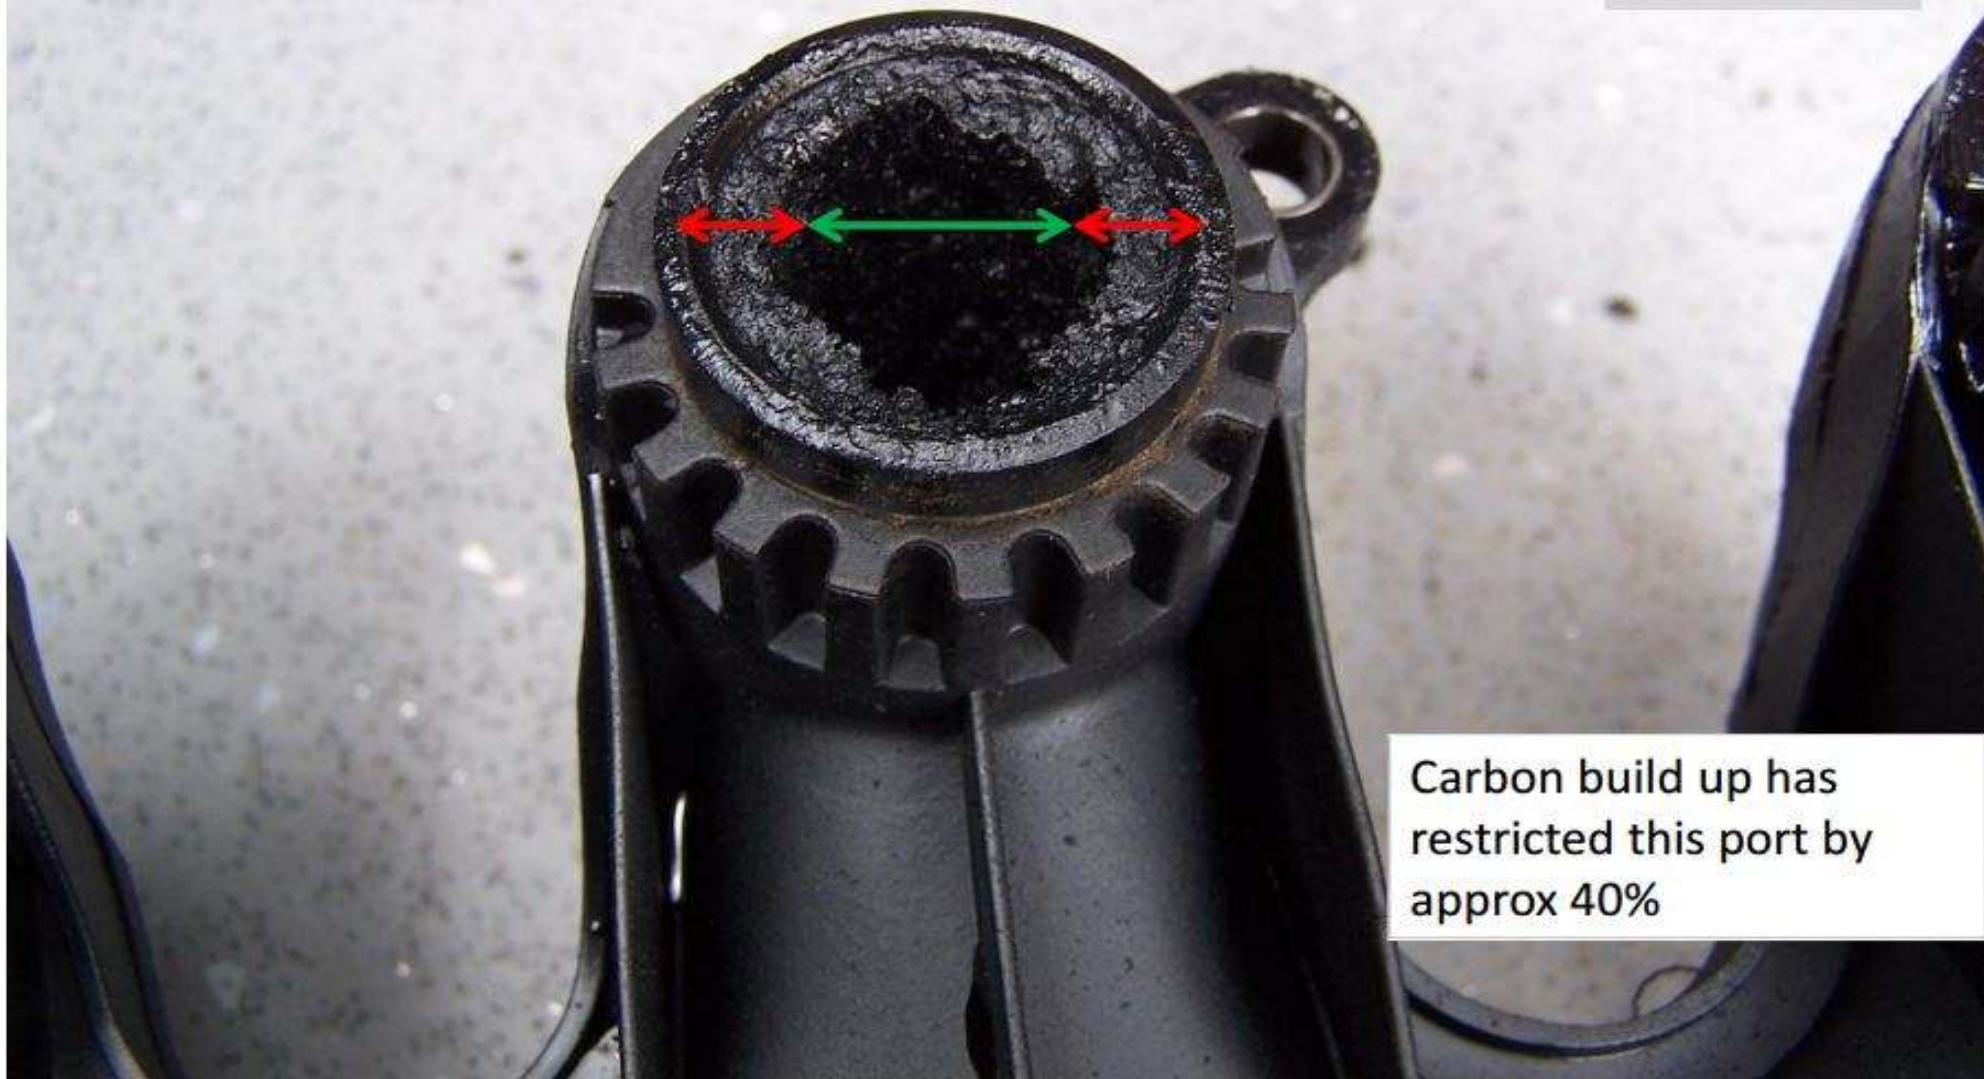
Overview:
**Engine
Breather
System**

Carbon build up has restricted this port by approx 40%

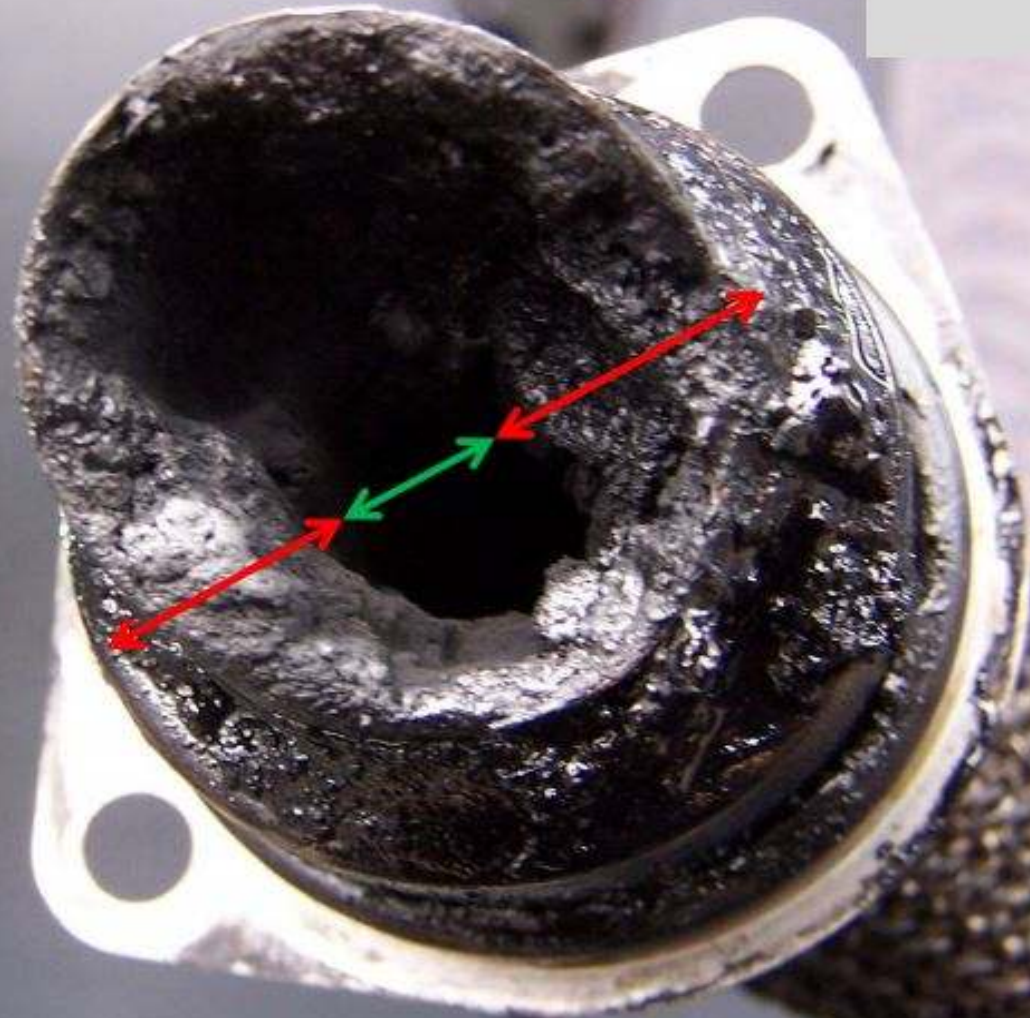
Overview:
**Engine
Breather
System**

Carbon build up has restricted this port by approx 70%

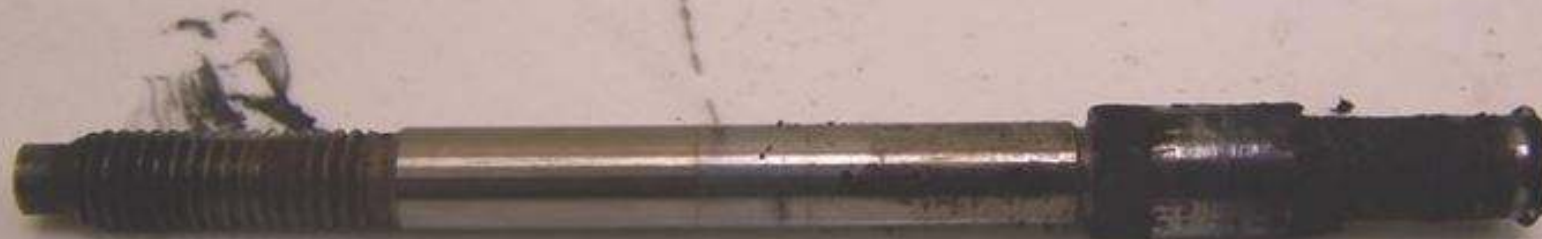
Overview:
**Turbine
Shaft**

Scoring to shaft and
burnt on carbon deposits

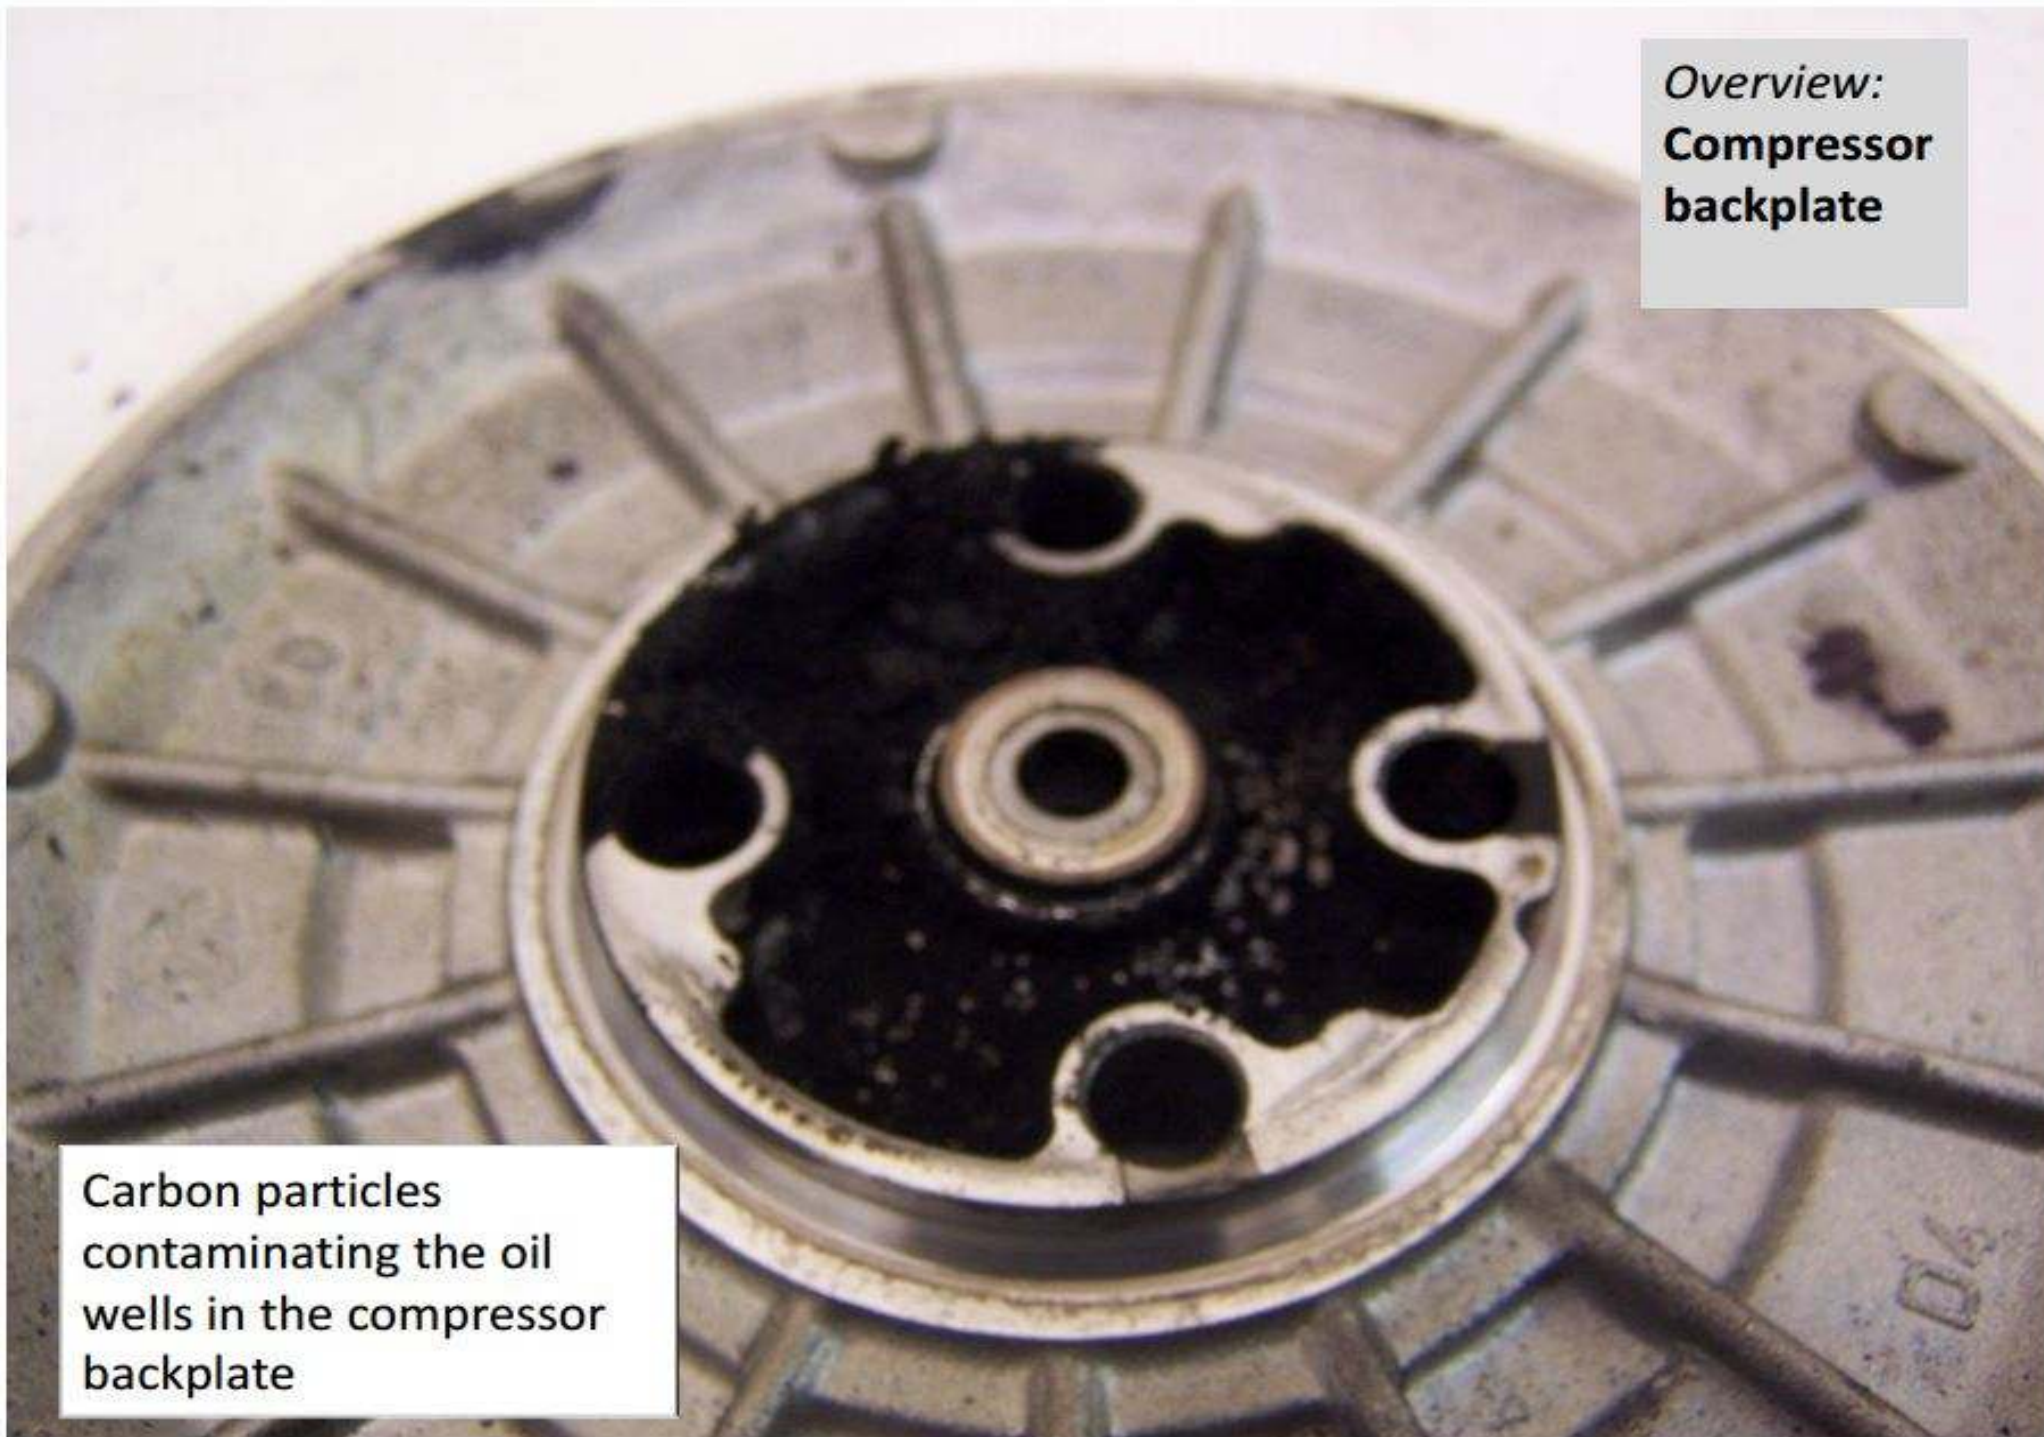
Overview:
**Compressor
backplate**

Carbon particles
contaminating the oil
wells in the compressor
backplate

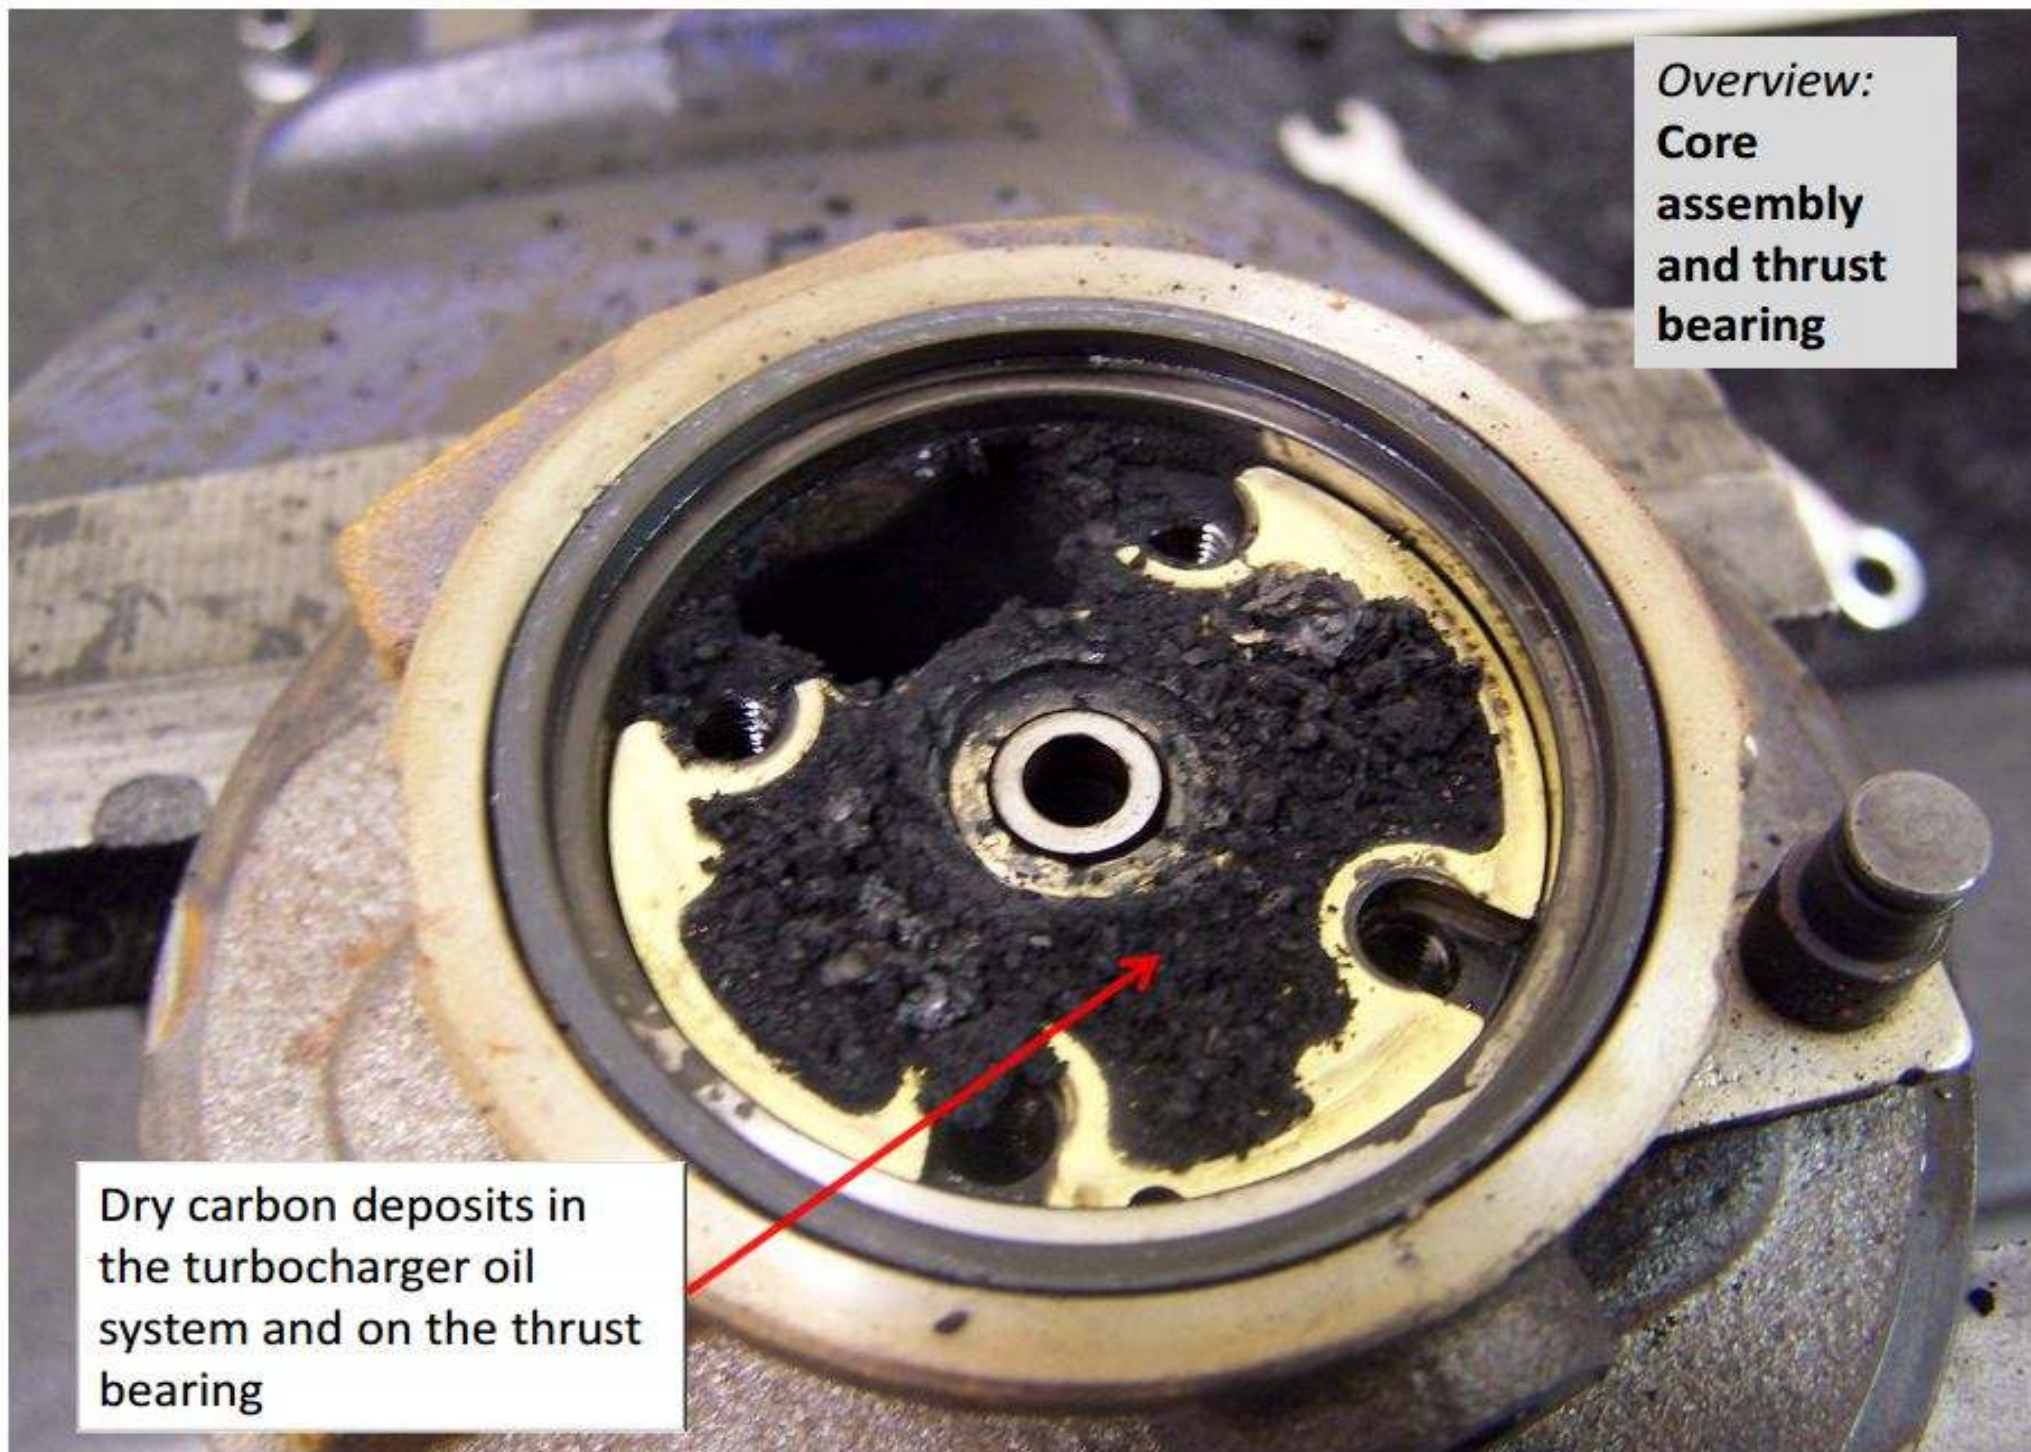
Overview:
**Core
assembly
and thrust
bearing**

Dry carbon deposits in
the turbocharger oil
system and on the thrust
bearing

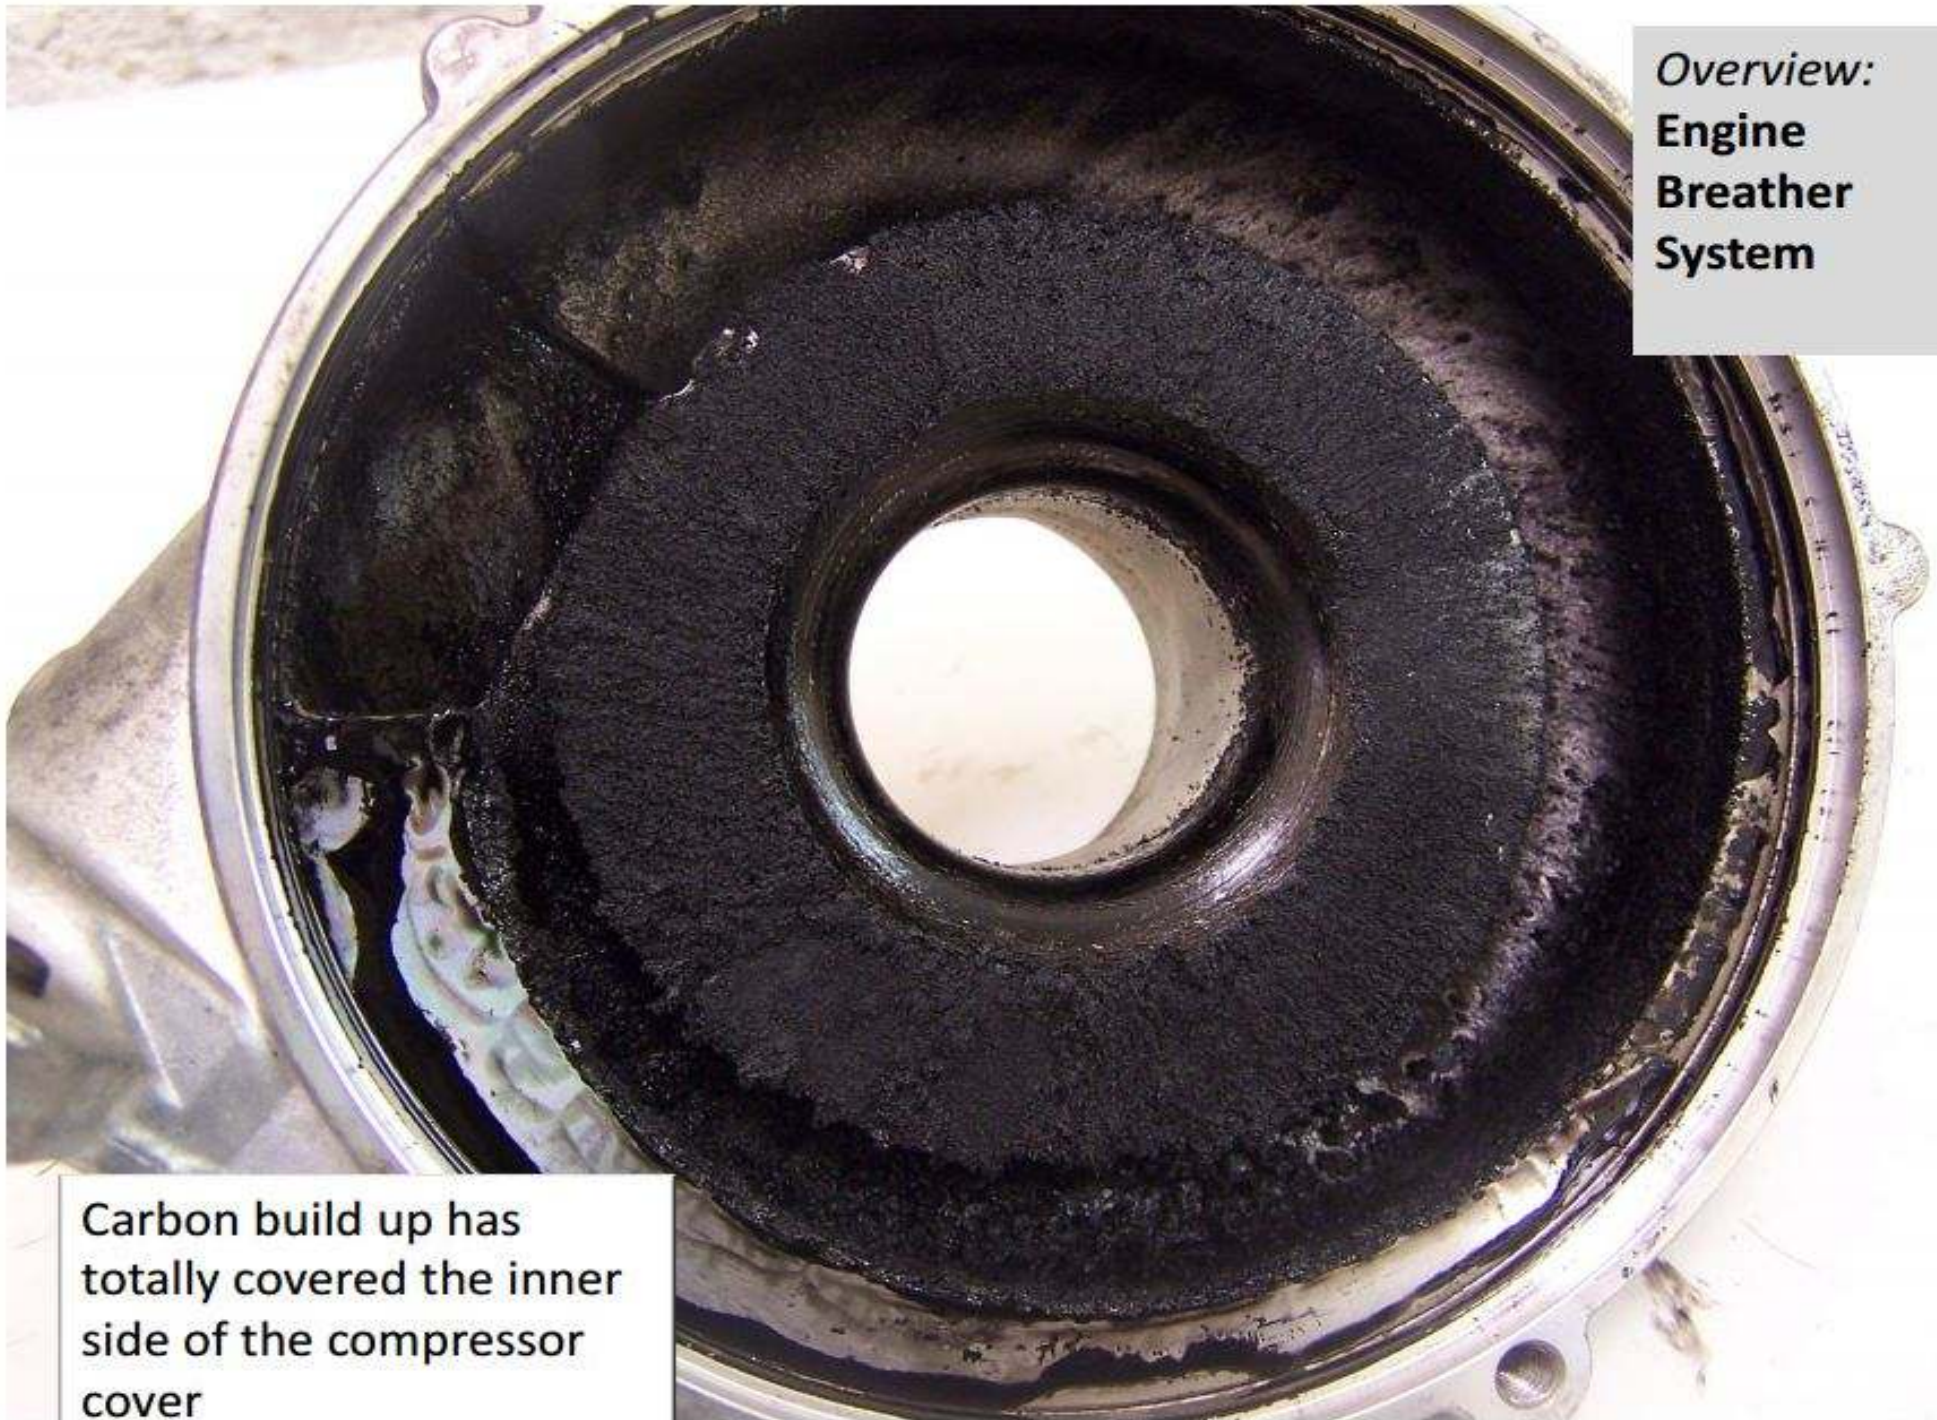
Overview:
**Engine
Breather
System**

Carbon build up has totally covered the inner side of the compressor cover
