1.6 HDi PSA Engine DV6TED4

**Evidence of carbon
build up in a 1.6 HDi
PSA Group engine
leading to total
turbocharger failure**

Case Study

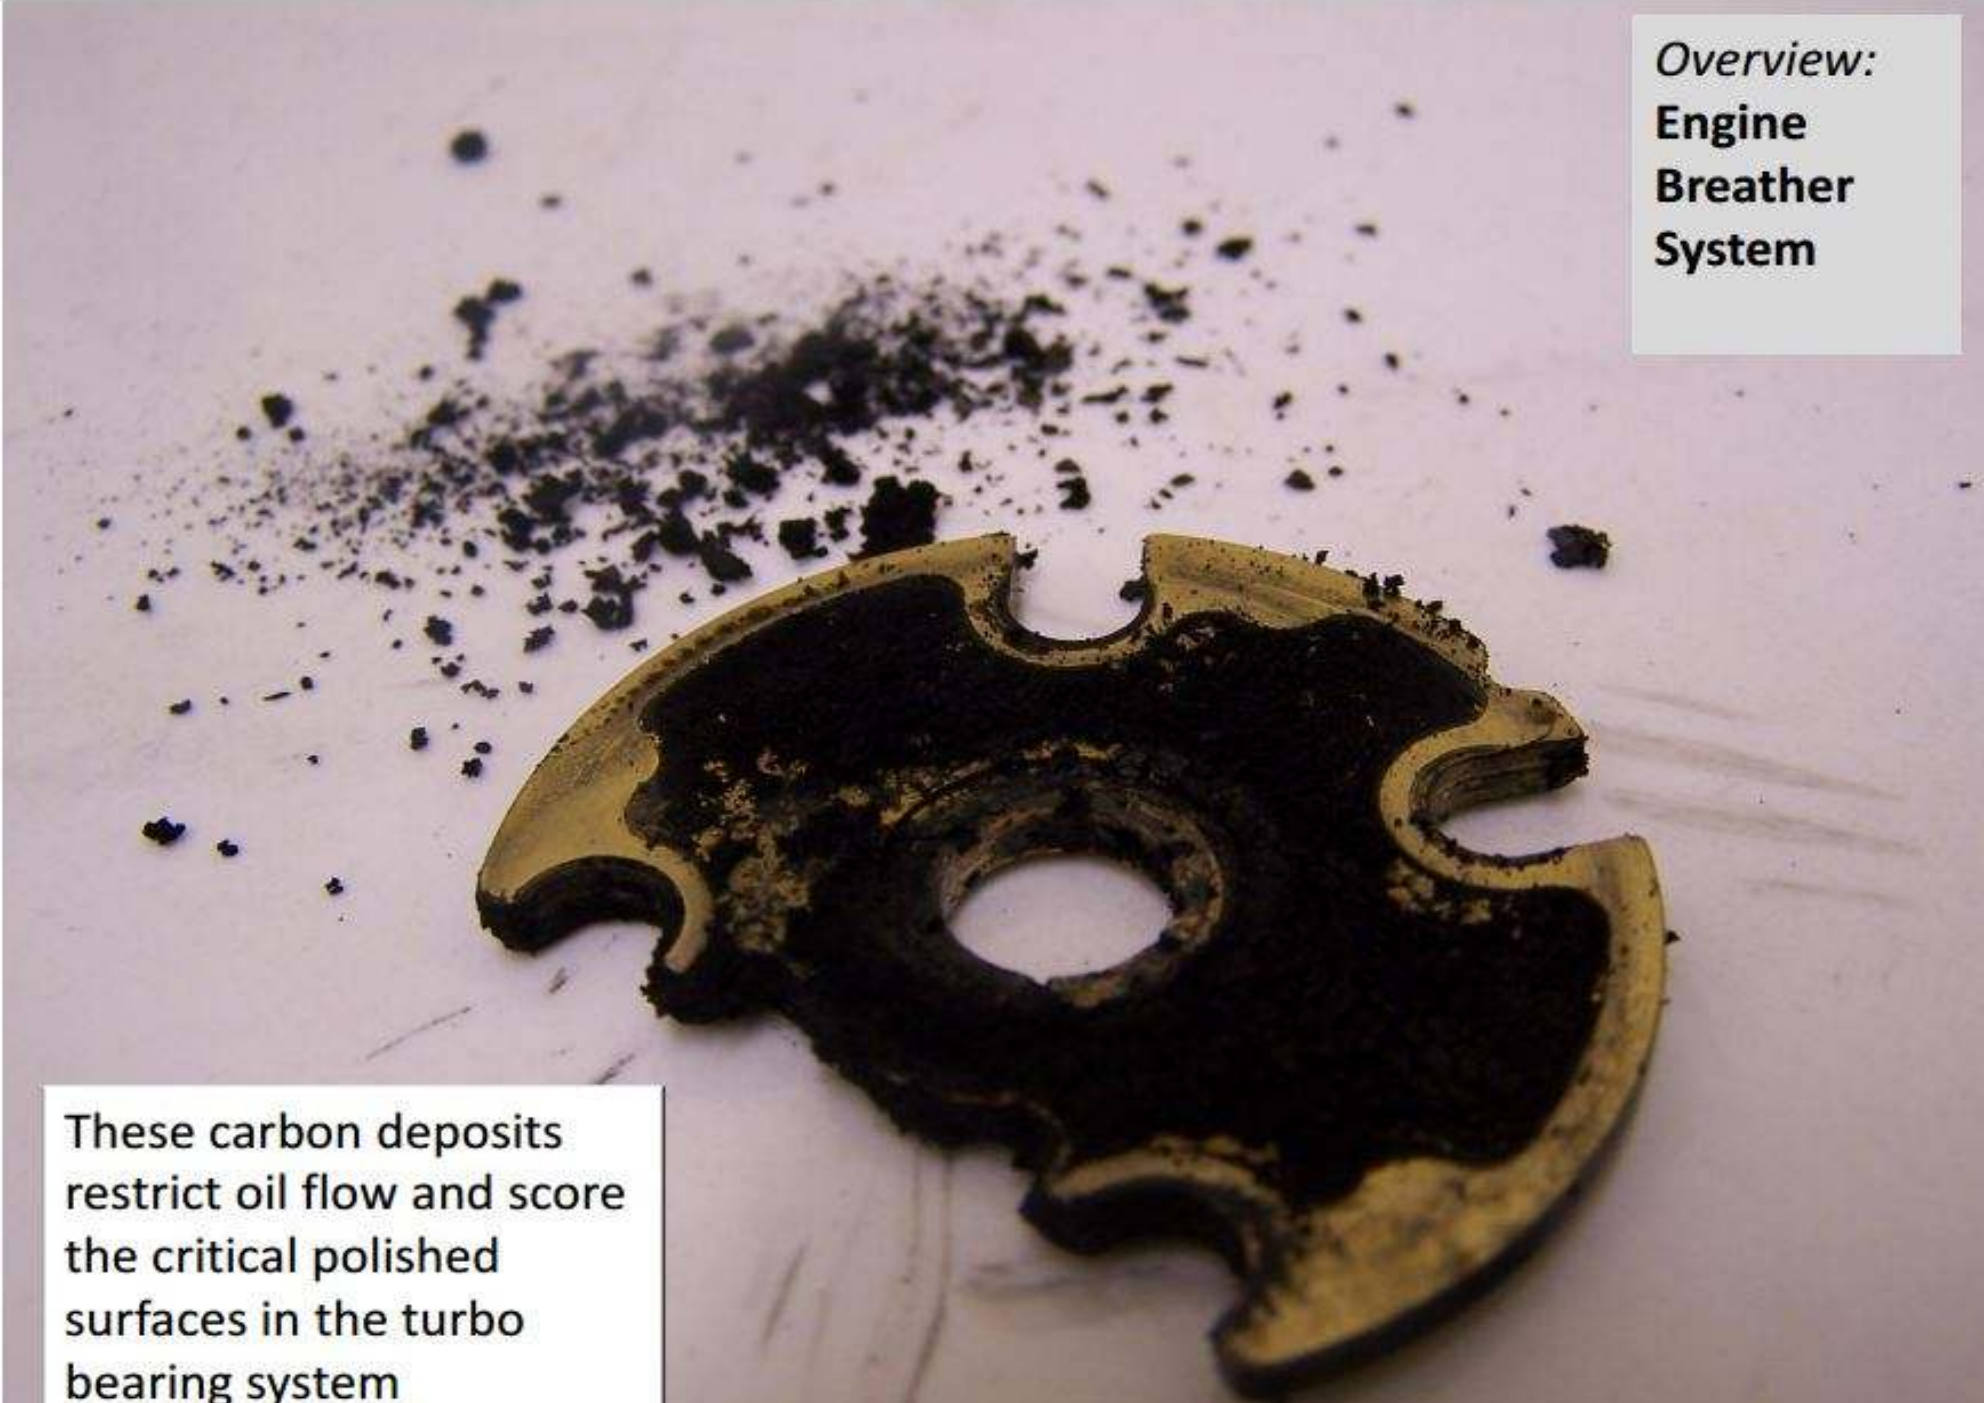
Overview:
**Engine
Breather
System**

These carbon deposits restrict oil flow and score the critical polished surfaces in the turbo bearing system

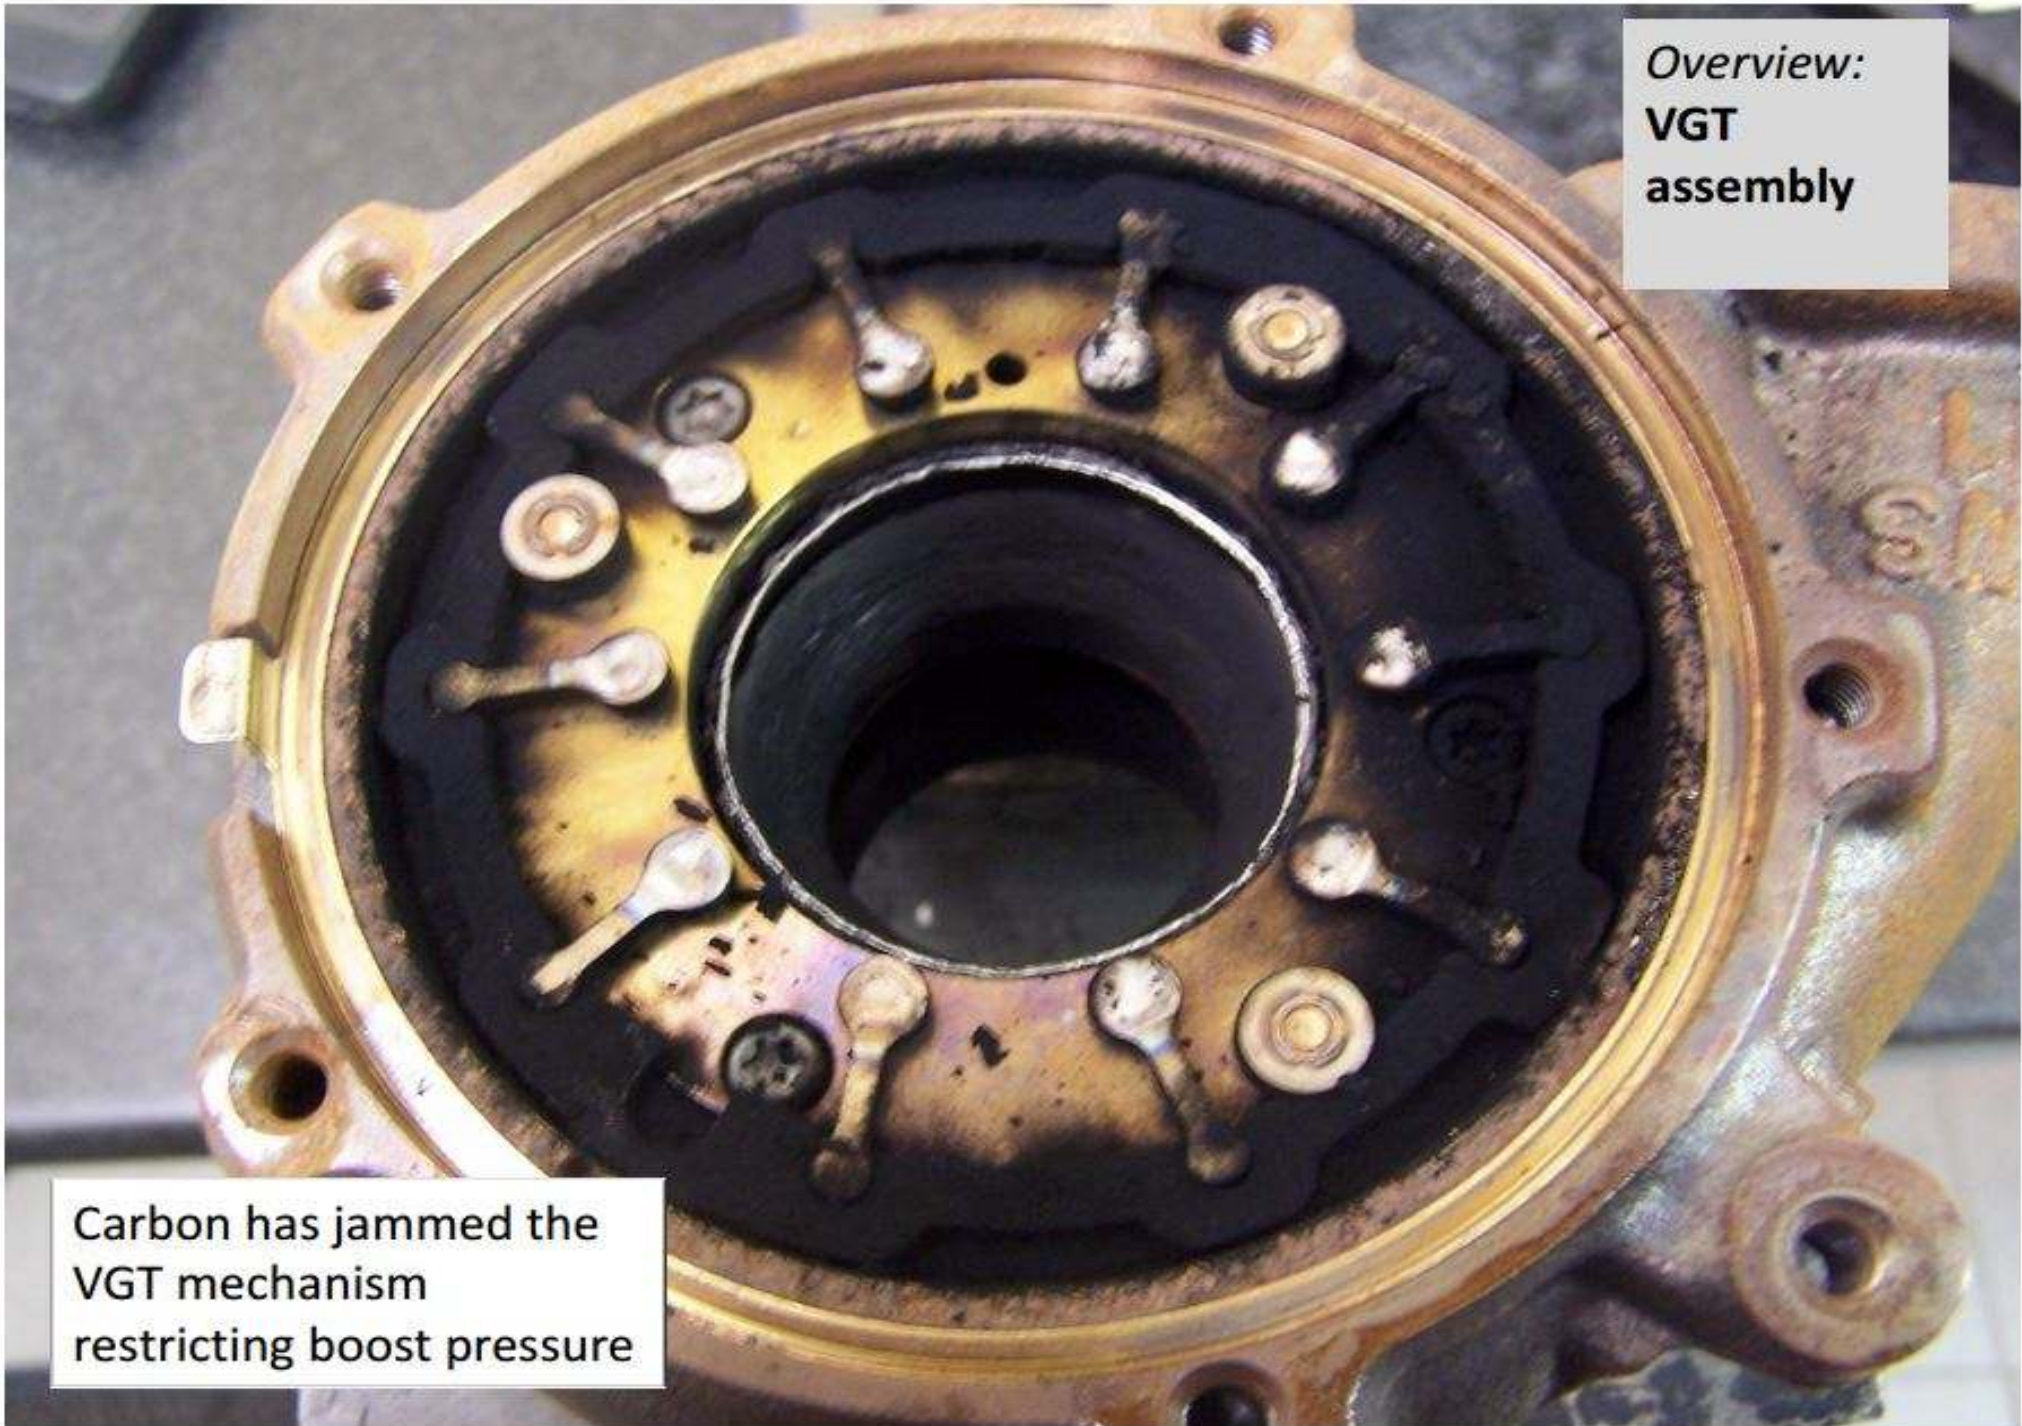
Overview:
**VGT
assembly**

Carbon has jammed the
VGT mechanism
restricting boost pressure
