1.6 HDi PSA Engine DV6TED4

**Evidence of carbon
build up in a 1.6 HDi
PSA Group engine
leading to total
turbocharger failure**

Case Study

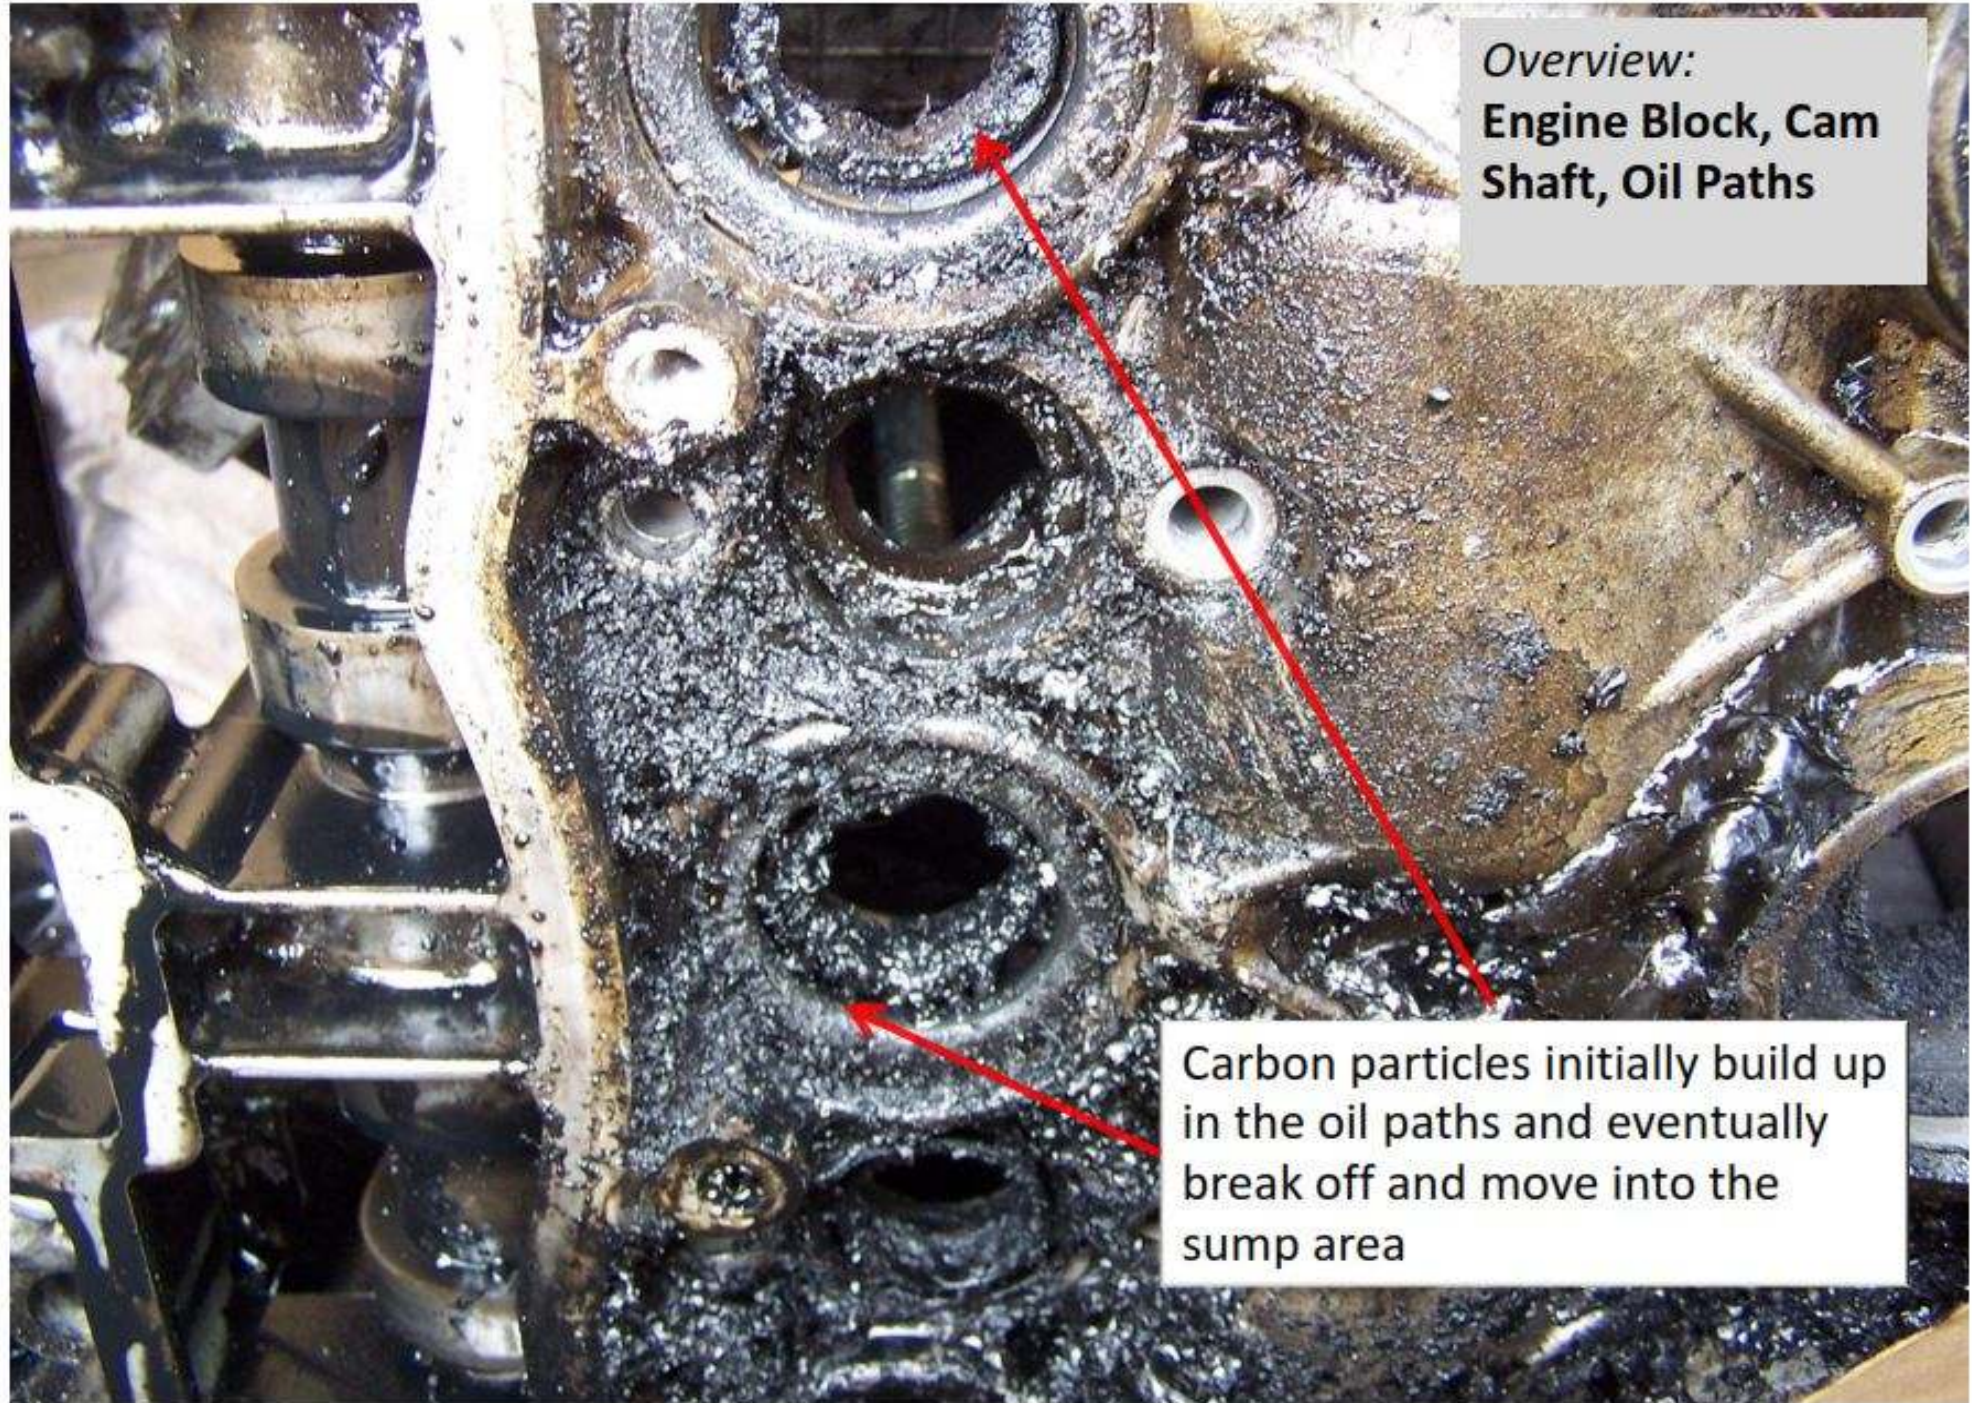
Overview:
**Engine Block, Cam
Shaft, Oil Paths**

**Carbon particles initially build up
in the oil paths and eventually
break off and move into the
sump area**

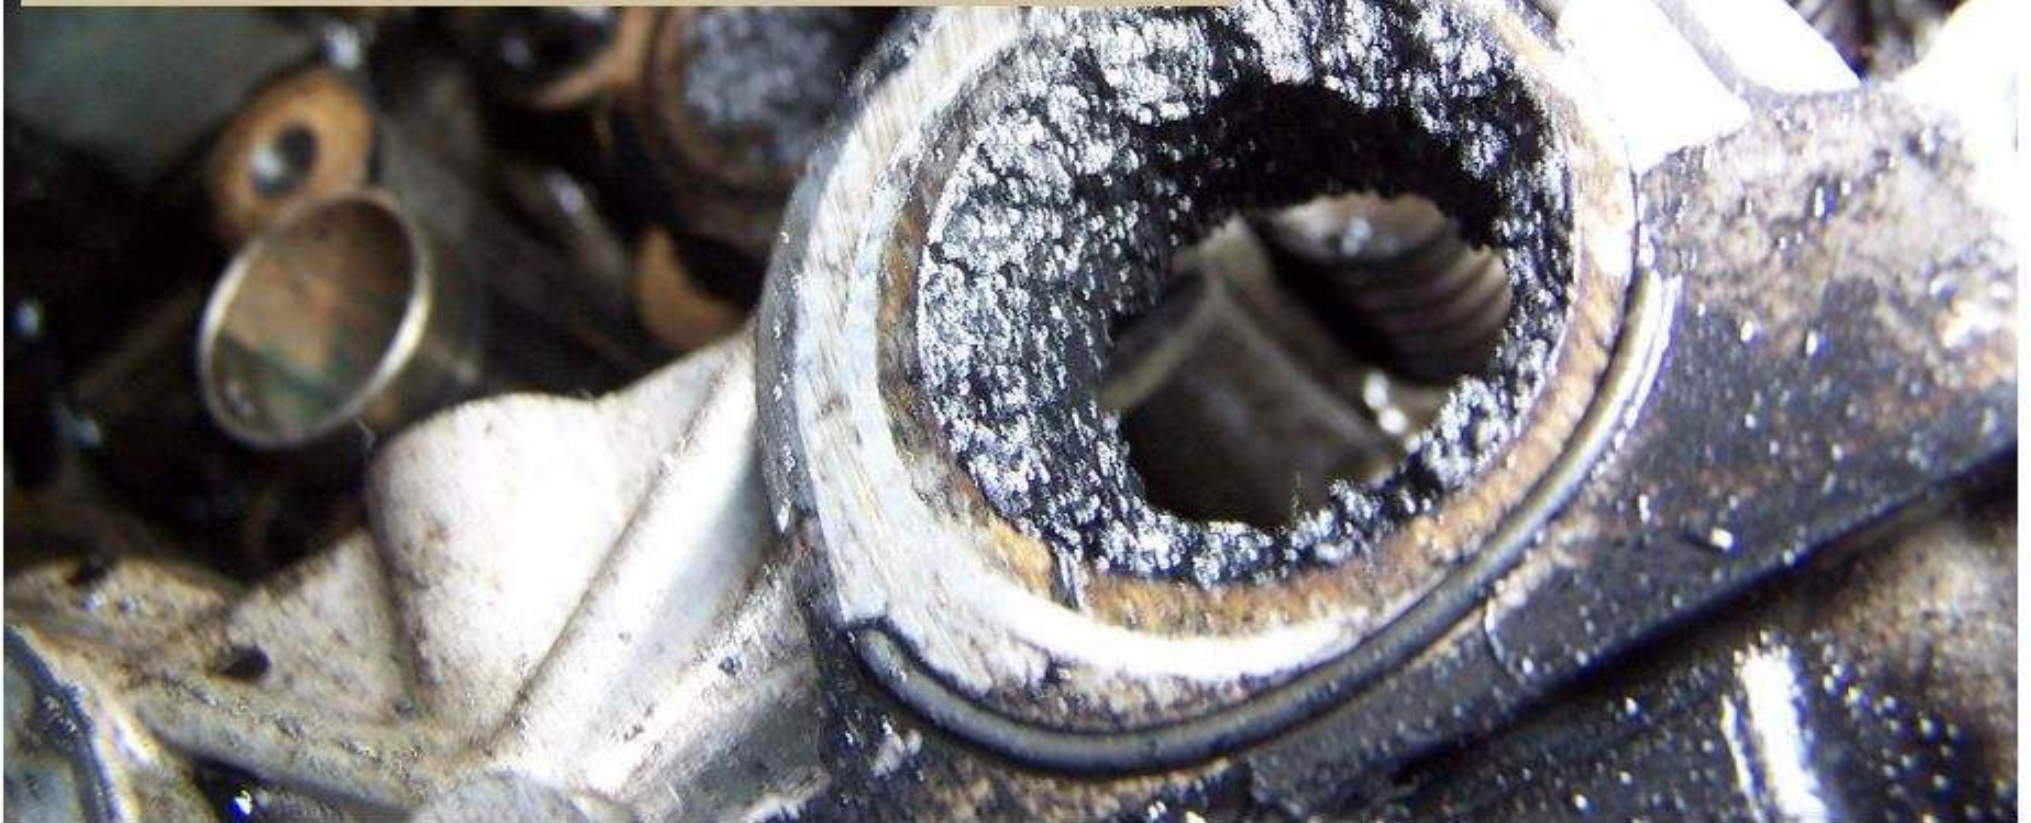
Overview:
Oil Paths

It is clear that the carbon remains even after 2 flushing procedures.....

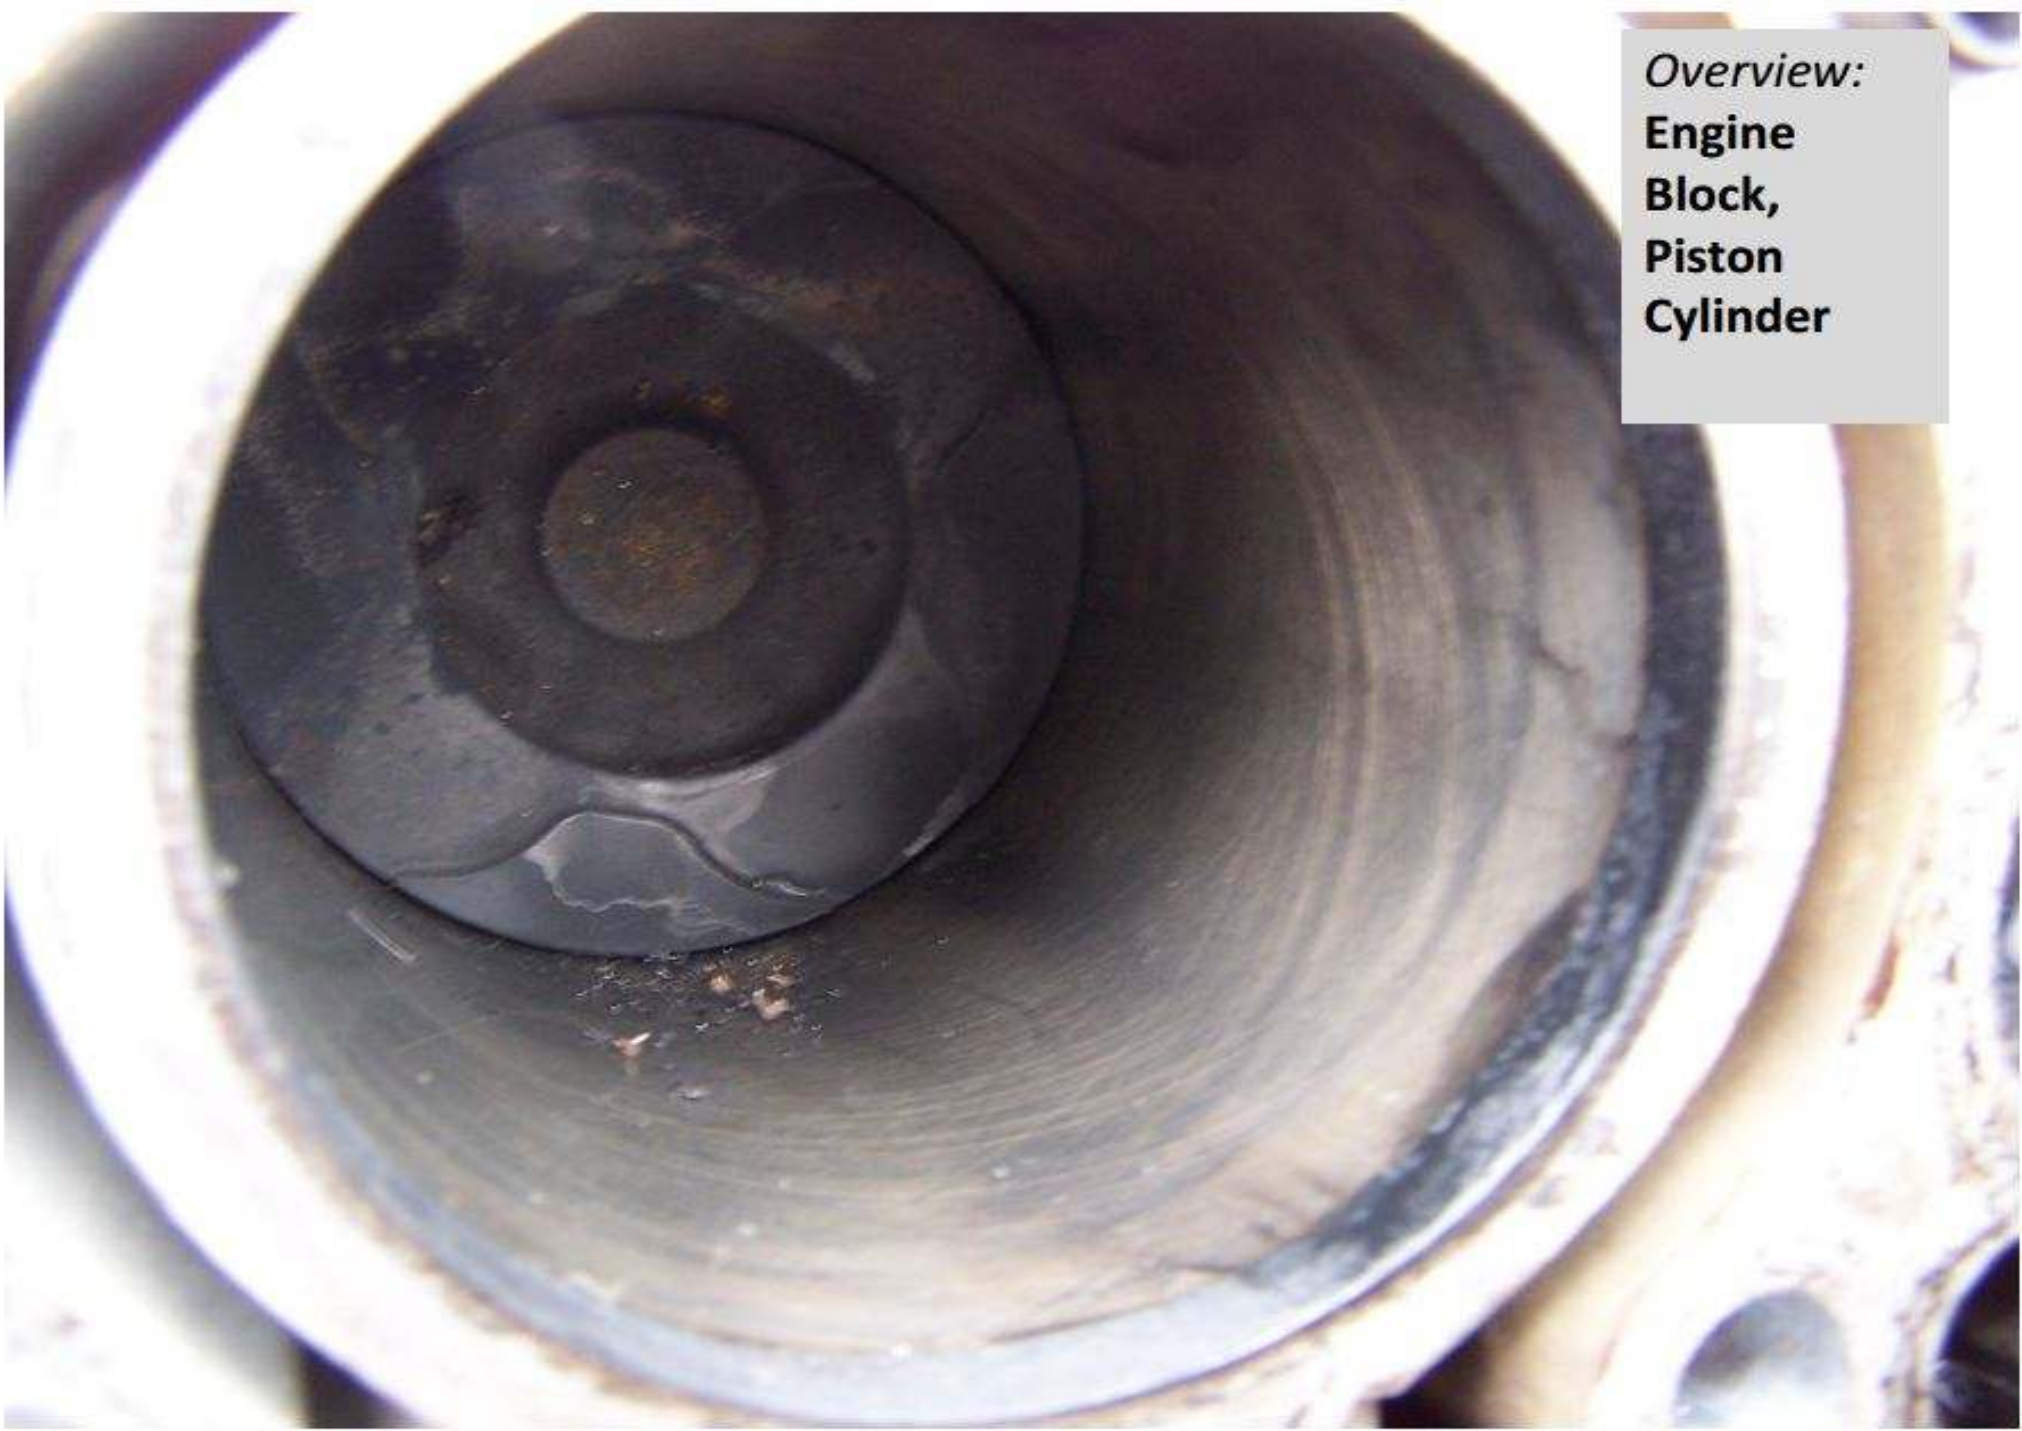
Overview:
**Engine
Block,
Piston
Cylinder**

There is a burnt carbon residue seen here on the upper end of the cylinder

There is also significant scoring to the piston/ cylinder area as a result of carbon particles

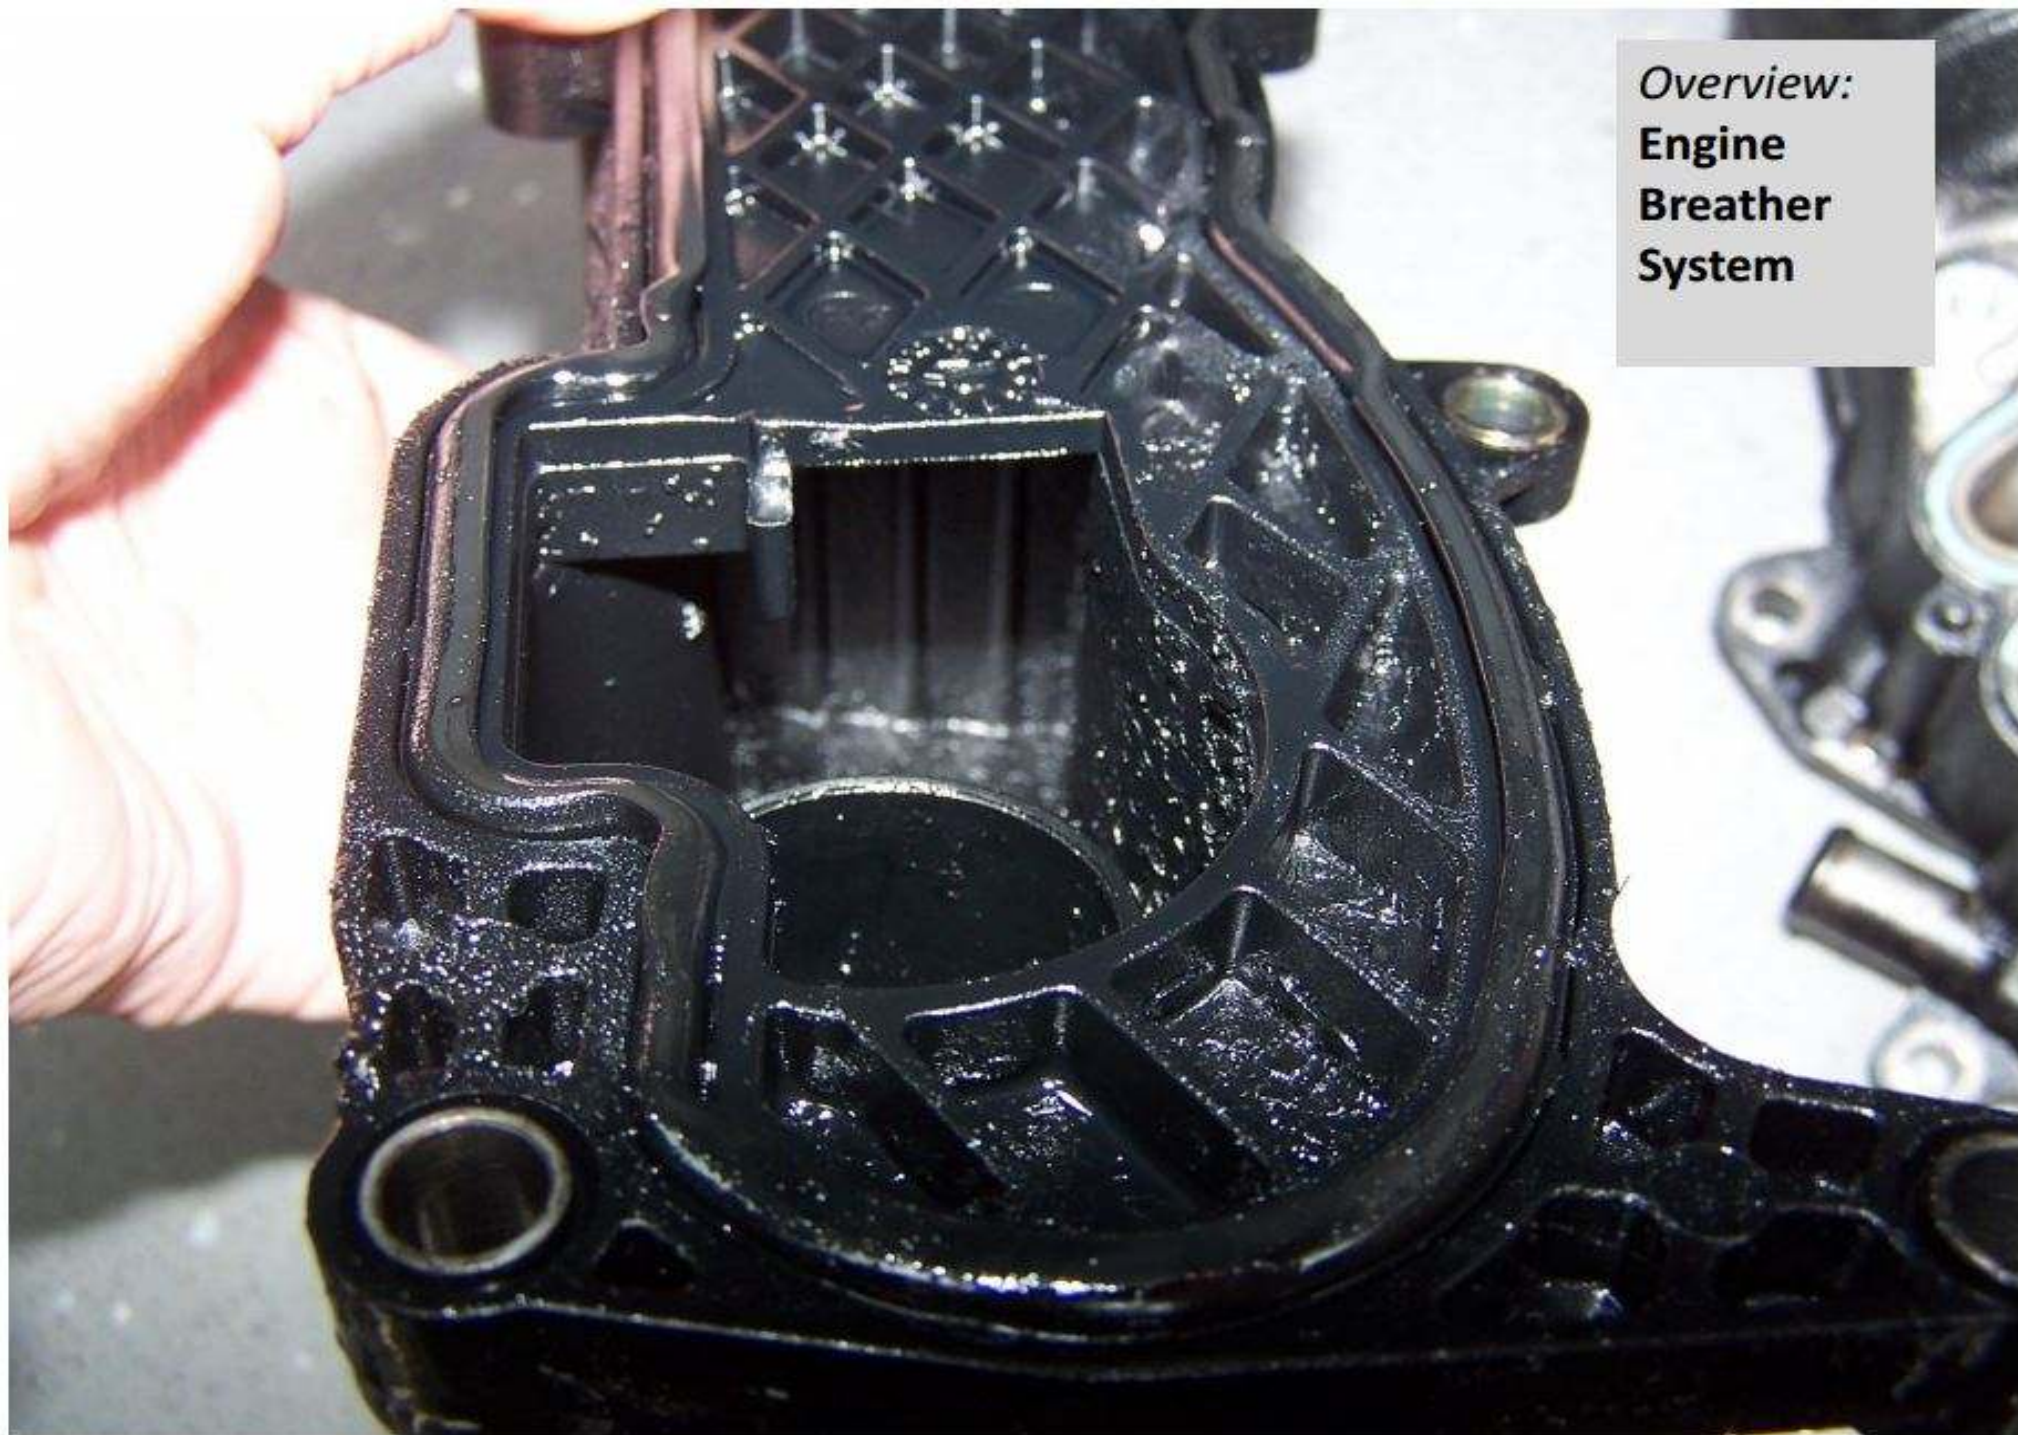
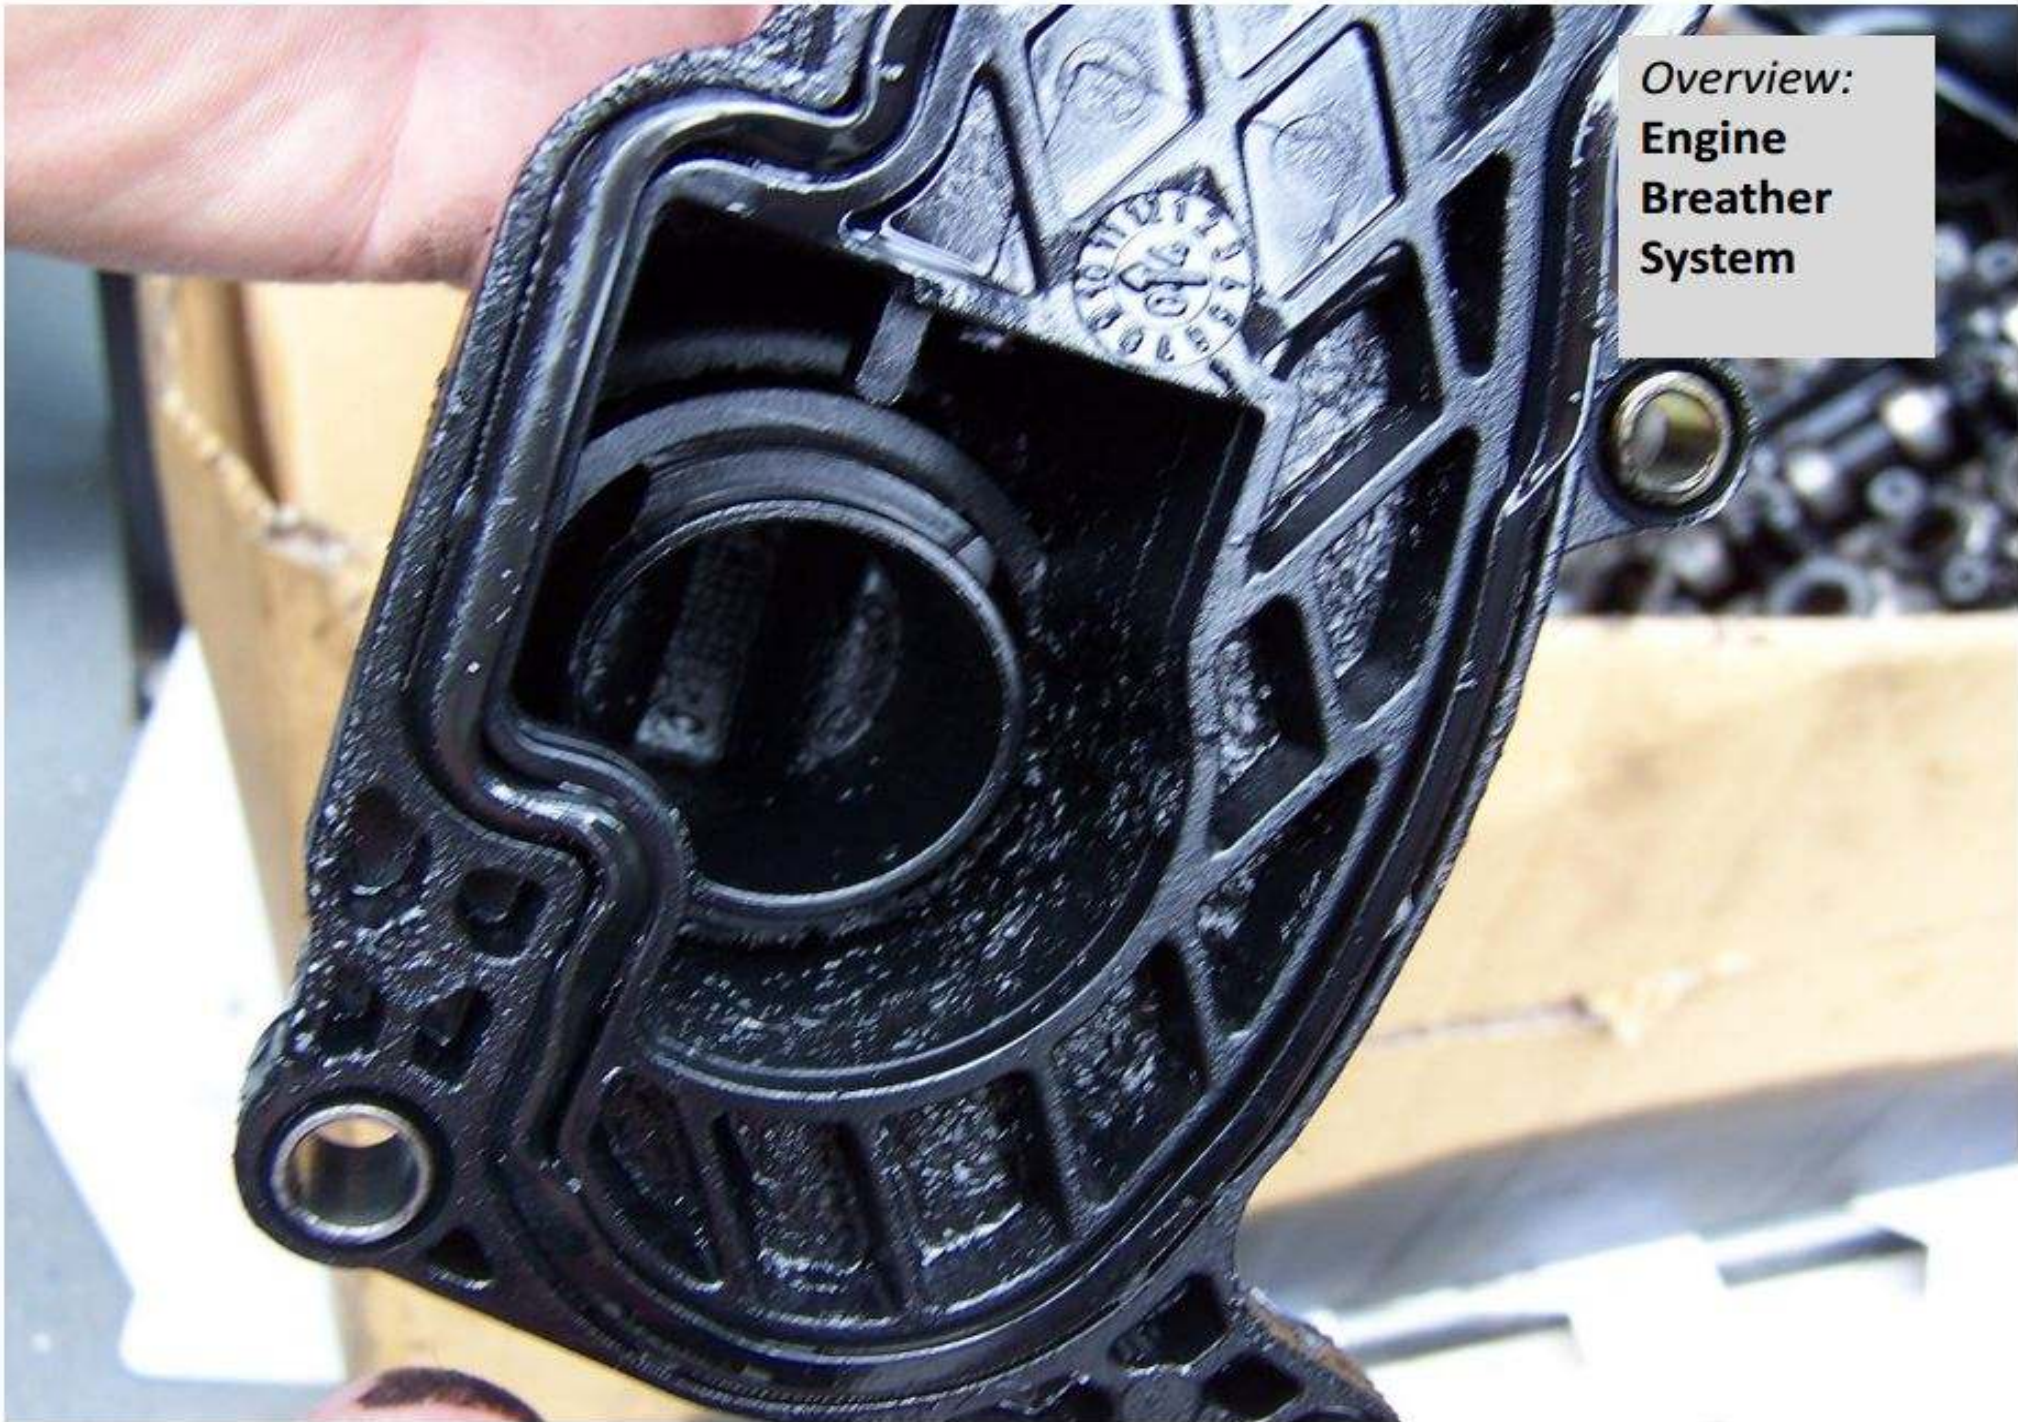
Overview:
**Engine
Breather
System**

Carbon build up in the engine breather system

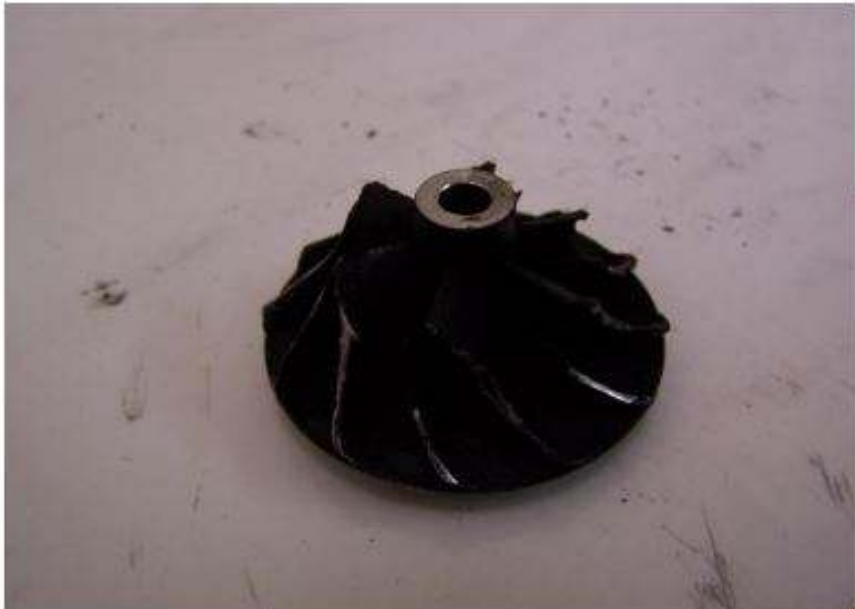
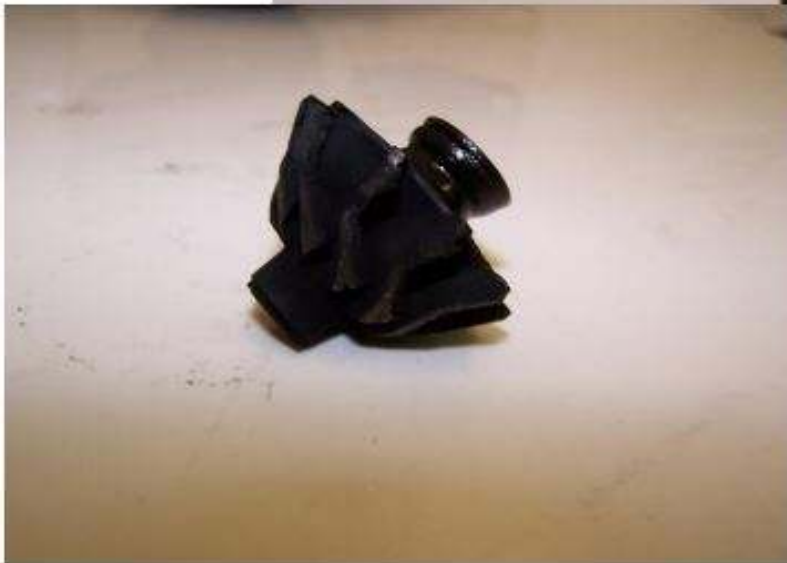
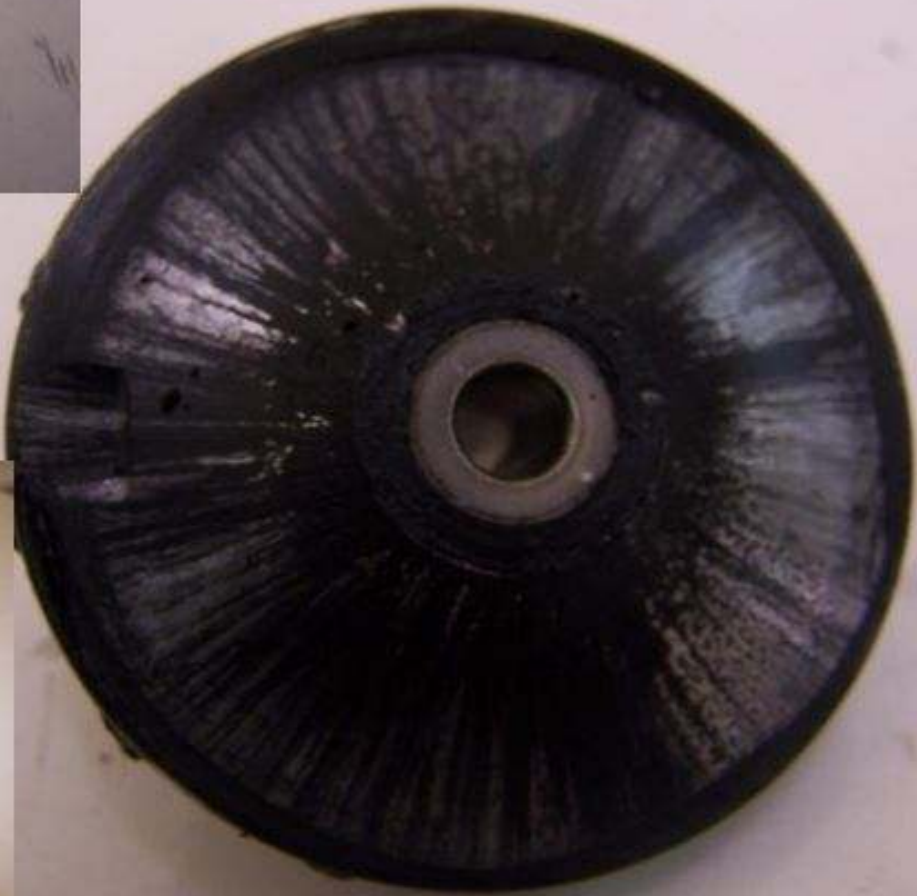
Overview:
**Compressor
and turbine
wheels**

These carbon deposits restrict oil flow and score the critical polished surfaces in the turbo bearing system
